# Slope Failures Evaluation and Landslides Investigation Using 2-D Resistivity Method

M.M. Nordiana and I.N. Azwin

Geophysics Program, School of Physics, Universiti Sains Malaysia  
11800 Minden, Penang, Malaysia

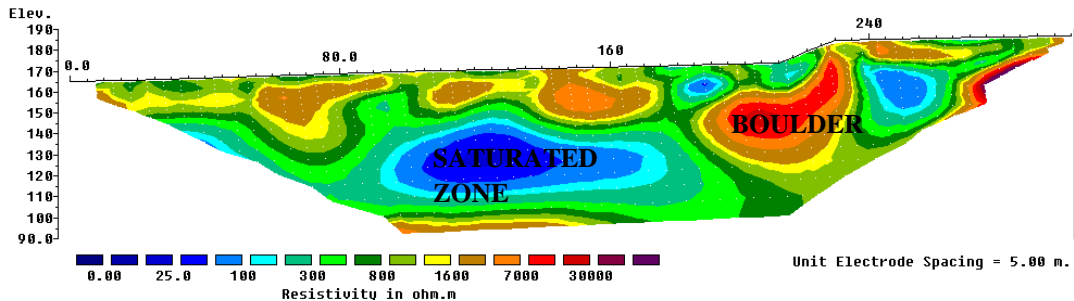
From the 2-D resistivity method, the inversion model resistivity for potential area, RL1 (outside collapsed area) (Figure 3) shows there are 2 main zones. The first zone is alluvium or highly weathered with resistivity values of 100-1000  $\Omega\text{m}$  and depth of 70 m. This zone consists of saturated zone (1-100  $\Omega\text{m}$ ) and boulders (1200-7000  $\Omega\text{m}$ ). The second zone with

resistivity value of  $> 7000 \Omega\text{m}$  which interpreted as granitic bedrock. A lot of small fractures can be seen around the study area as shown in Photo 1.

Figure 3: Inversion model resistivity in Selangor for RL1 (outside collapsed area).

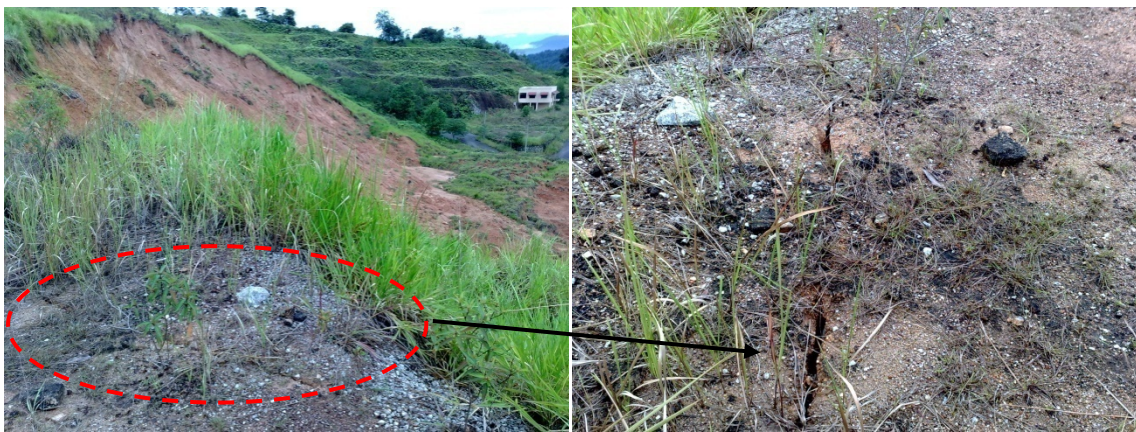
Photo 1: Small fractures located at the collapsed area in Selangor.

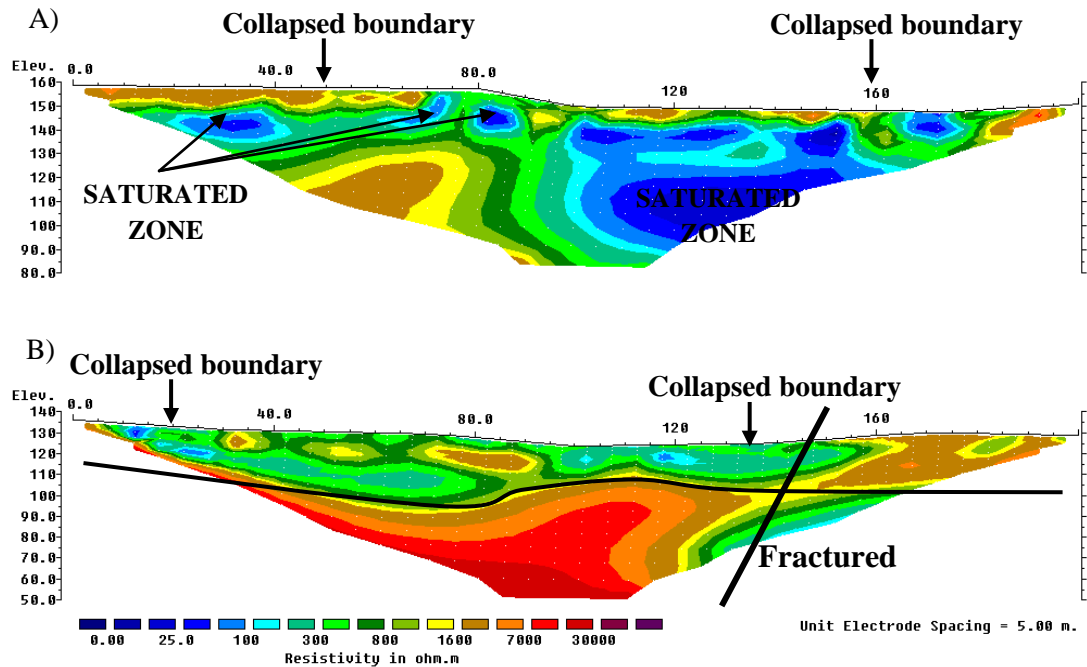
Figure 4 shows the inversion model resistivity of RL2 and RL3 which has two main zones. The first zone is alluvium or highly weathered with resistivity value of  $100\text{-}1000 \Omega\text{m}$  and depth of  $30\text{-}70 \text{ m}$ . RL2 shows saturated zone while RL3 consists of alluvium or highly weathered zone. Boulders and fractures were located outside the collapsed area with resistivity value of  $1200\text{-}7000 \Omega\text{m}$ . Alluvium may consist of clay, sand and silt. Rainfall is also one of the factors that may cause to the instability of the slope. Seasonal high rate of rainfall, allowing part of the soil possibly to become fully saturated several times during wet seasons of any year. The study area is either decomposed volcanic rock (silt) or decomposed granite (silty sand) and both soils have high strength when unsaturated during dry season but

a low strength when fully saturated. The saturated zone, boulders and highly weathered rock will trigger the slope failure.

Figure 4: Inversion model resistivity in Selangor; A) LR2 and B) LR3.

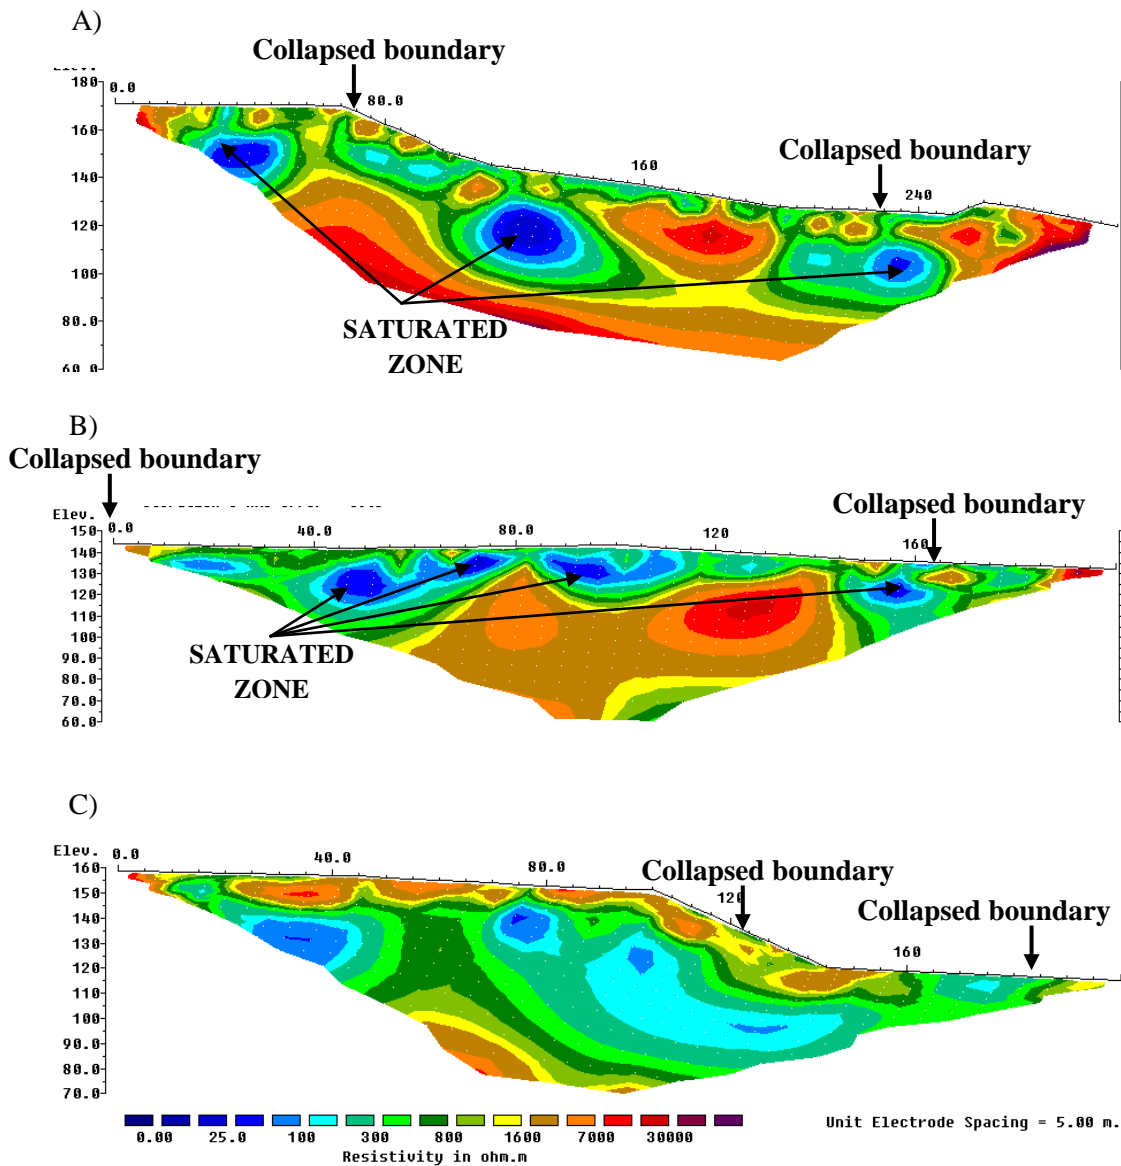
Inversion model resistivity of RL4-RL6 shows two main zones (Figure 5). The first zone with resistivity values of 100-1000  $\Omega\text{m}$  was interpreted as alluvium or highly weathered rock with depth of 20-70 m. The zone consists of saturated zone and boulders with resistivity value of 1-100  $\Omega\text{m}$  and 1200-7000  $\Omega\text{m}$  respectively. Second zone is granitic bedrock with resistivity value of  $>7000 \Omega\text{m}$ .

Figure 5: Inversion model resistivity in Selangor; A) RL4, B) RL5 and C) RL6.

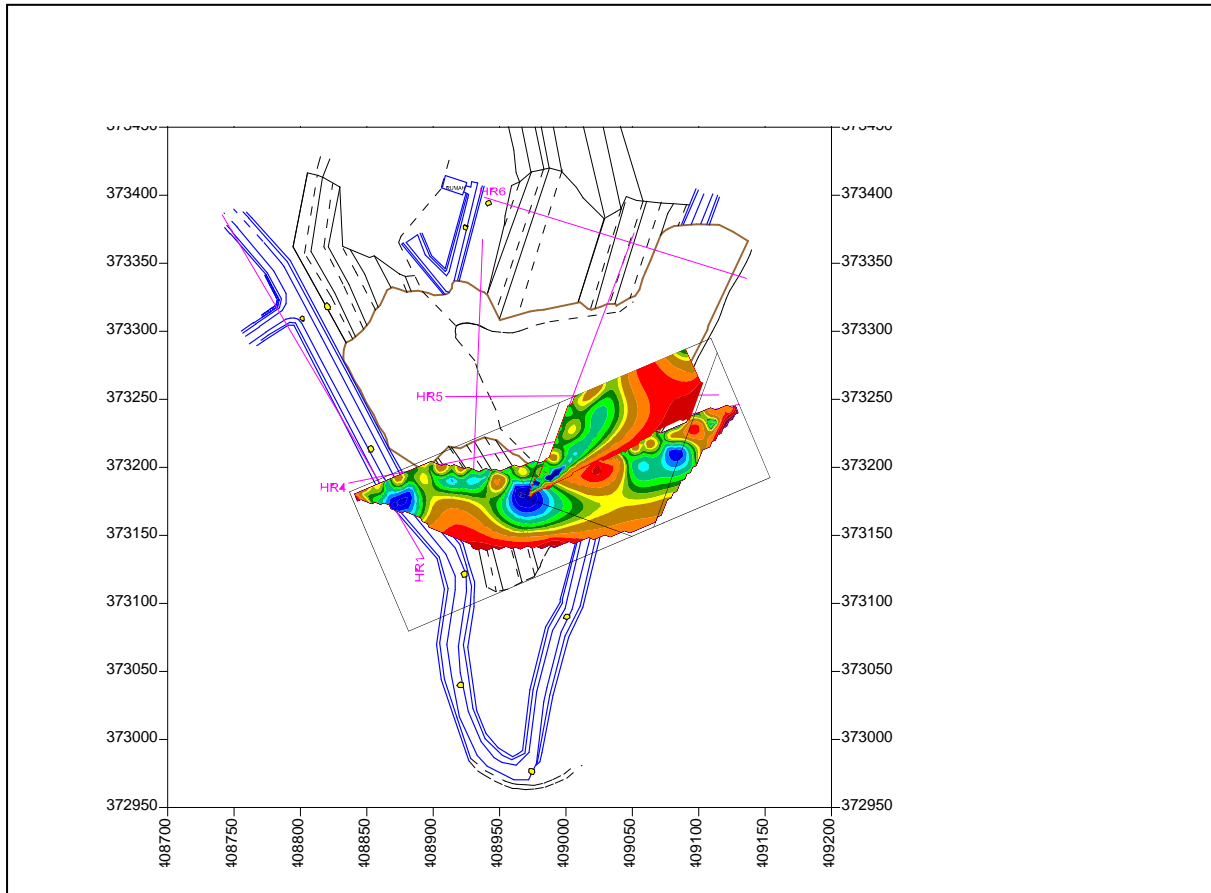
Generally the results show that the study area consists of high resistivity value, it might due to sand. It was observed that the topsoil was characterized by isolated low resistivity materials that were identified as saturated zones, highly weathered zone and boulders. The saturated zone might be due to the present of Gapis River as shown in Figure 6. The higher the porosity will give higher permeability. Porosity can be a factor in permeability. Water flows quickly through material with high permeability. The Gapis River can be easily flow in the study area due to the sand contained. These low materials overlie the

bedrock produce unstable slope which trigger slope failure and may cause to landslides in the study area.

Figure 6: The arrangement of inversion model of resistivity with underground water from Gapis River.
