**SLOPE IMPROVEMENT TECHNIQUE USING 8R
MAT SYSTEM**

UNIVERSITI SAINS MALAYSIA

**Thesis submitted in fulfillment of the
requirements for the degree of
Master of Science**

September 2016

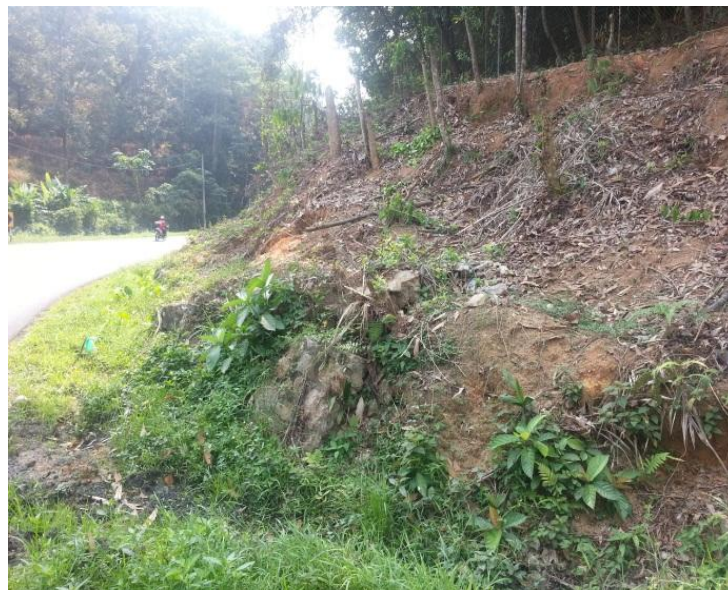
Plate 1.1: Failed slope at Jalan Junjong, Kulim

During the site visit, it was observed that the slope condition was quite critical and some preventive measures needed to be done. The slope was suggested to be reinforced with the 8R mat system and the District Engineer agreed on this collaboration with the
