Construction Considerations for Low-Cost Earth Brick Shells

*Ryan Anthony Bradley¹, Mitchell Gohnert¹ and Ivanka Bulovic²

To cite this article: Ryan Anthony Bradley, Mitchell Gohnert and Ivanka Bulovic (2018). Construction considerations for low-cost earth brick shells. *Journal of Construction in Developing Countries*, 23(1): 43–60. <https://doi.org/10.21315/jcdc2018.23.1.3>.

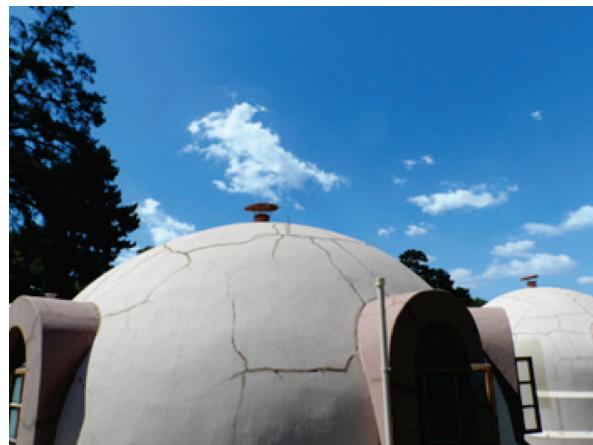
Figure 1. Surface Cracking Over a Dome at the Sparrow Rainbow Village

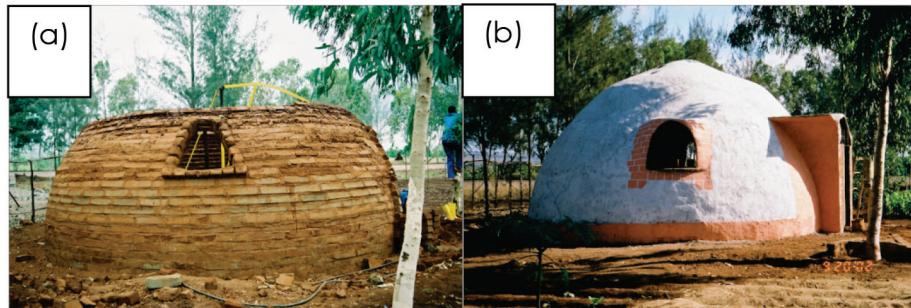
Figure 2. Free-Hand Construction of an Earth Brick Masonry Dome: (a) Construction with Cupola Tracer and (b) Errors at the Apex of the Completed Dome

A number of simple, and rather more complex, tools have been developed for the precise placement (i.e. at the correct position and inclination) of masonry units. The "cupola tracer" is one such device, which enables the rapid construction of brick courses: see Figures 2(a) and 2(b). Gohnert and Magaia (2004) discuss the design and construction of a low-cost CSEB masonry dome built near Maputo, Mozambique, using the "cupola-tracer" technique. The construction of the CSEB dome is shown in Figure 2(a). Magaia (2003) notes, reflecting on the difficulties during construction, that the top closure of the dome is one of the most critical points in this process. Specifically, near the top of the dome the "cupola-tracer" is

no longer useful, because the adhesion, between CSEB and mortar, is insufficient to prevent the bricks from sliding off. Consequently, the top section had to be built over shaped earth, which required horizontal support through propped formwork. However, some subsidence of the soil occurred near the apex of the dome during the removal of the formwork, which lead to the errors shown in Figure 2(b).

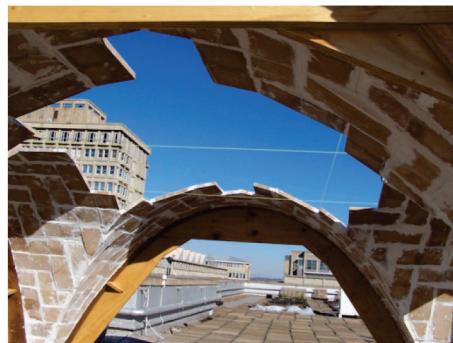
Figure 3. Freehand Construction of an Earth Tile Cross-Vault

The Mapungubwe shells were built without formwork or centring: construction was done by sighting between completed portions and curved plywood guides (Fitchett, 2009). The first layer of compressed stabilised earth tiles was placed by hand, using rapid setting gypsum (Crystacal). This layer then provides the "formwork" for successive layers, which were laid with typical cement-sand mortar, until the required thickness was achieved. Chothia (2010) and Gohnert et al. (2013) describe the construction of two earth-tile cross-vaults, built at the University of the Witwatersrand, using similar techniques to those used for the construction of the Mapungubwe shells. An image illustrating the free-hand construction of one of these shells is shown in Figure 3.

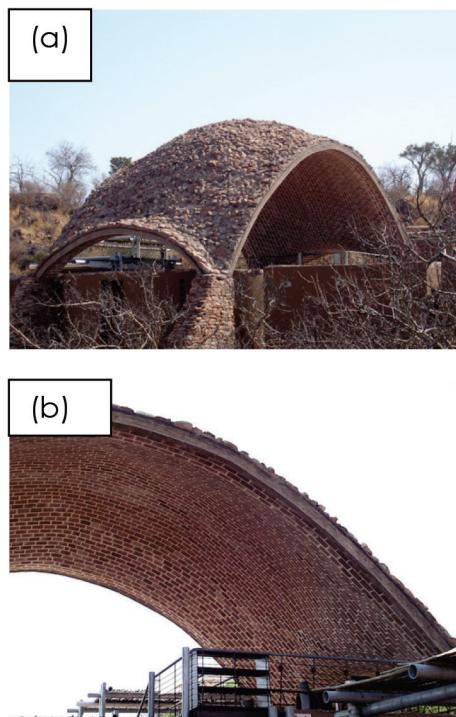
Figure 4. Large Earth Tile Structure: Mapungubwe Interpretation Centre – (a) Large Free-Spanning Shell and (b) Shell Undulations

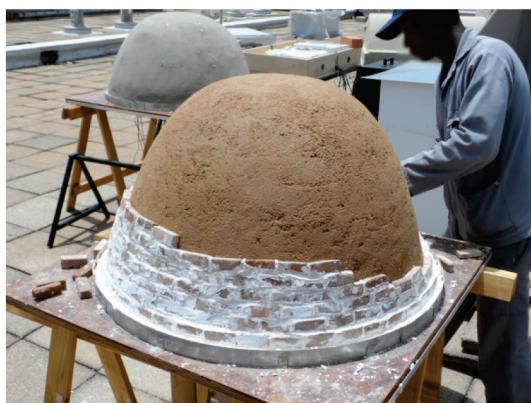
Figure 5. Small Dome Built with Earthen Formwork

The application of this technique to masonry shell construction is relatively simple: moist soil is shaped into a form defining the intrados of the shell and the masonry is subsequently built over this form. Bricks or some other supporting structure can also be used to occupy part of the internal volume in order to limit the amount of soil (and consequently work) required. Figure 5 shows a model catenary dome built using this technique. Moist sand was placed over and around an inverted bucket and shaped with a wooden catenary cut-out to attain the desired shape.

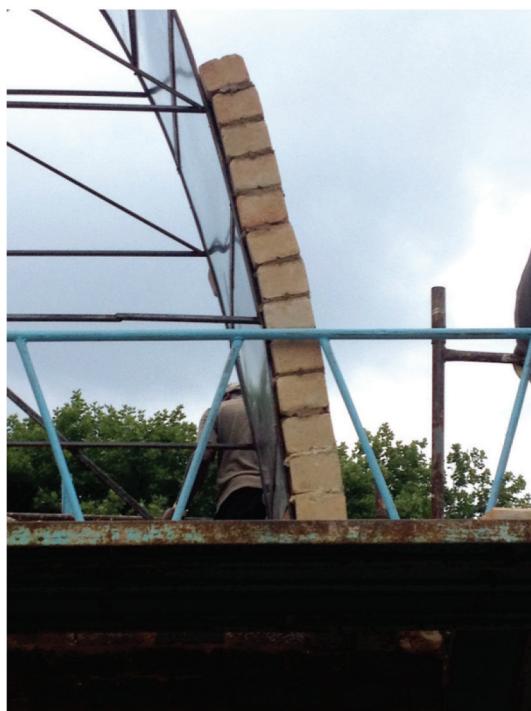
Figure 6. Issues with the Construction of the Wits Shells

Another advantage of adopting prefabricated formwork is that its use may greatly improve the accuracy of construction; however, accurate formwork alone does not guarantee a high quality of work. Figure 6 shows the first segment of a vault built with formwork at the University of the Witwatersrand. The vault was built by bricklayers accustomed to typical vertical wall construction, and consequently this "unusual" technique required some practice in order to lessen the chance of mistakes. One such mistake (i.e., a kink) is clearly apparent in Figure 6. At times, several layers of bricks had to be removed and rebuilt to rectify these errors. These initial segments came to be a learning experience for the bricklayers, and the remaining work, in the most part, was completed quickly and accurately. These lessons highlighted the importance of experience (and skill), as well as the need for continuous monitoring to ensure that any inaccuracies in the form are identified immediately, before significant remedial action is required.

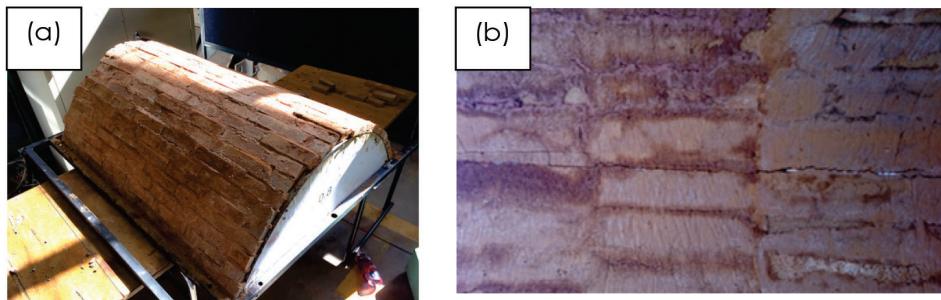
Figure 7. Model Catenary Vaults Built Over Rigid Formwork: (a) Shrinkage Prevented by Rigid Formwork and (b) Apex Crack (Internal Surface)

Several small-scale earth-brick vaults were built to explore the cause of cracking observed in the Wits shells. The materials used to build the model were compressed cement stabilised earth tiles and class II mortar (as specified in BS 5628): see Figure 7(a). Two distinct setups were adopted: namely, (1) formwork left in place overnight and (2) formwork dropped after the initial set of the mortar (typically 90 minutes after construction had been completed). The following day, longitudinal cracks, through the entire thickness and along the apex, were only present in vaults in which formwork was left in place. An apex crack observed in one of these models is shown in Figure 7(b) (internal surface).

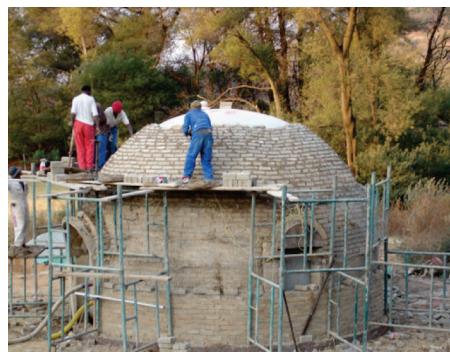
Figure 8. Construction of a Masonry Dome with Inflatable Formwork

Although this method has been widely adopted for the construction of small to very large concrete shell structures, it has only recently been utilised for standard (e.g., fired clay or cement brick) and earth masonry structures. Numerous cement-brick masonry domes were successfully built by Dome Space (South Africa) using inflatable formwork at the Sparrow Rainbow Village, Johannesburg (Talocchino, 2005). Understandably, due to the different building requirements for masonry, when compared with shotcrete, construction of masonry domes takes place from the outside. Gohnert and Talocchino (2011) discuss the use of this method to construct a small low-cost earth-brick dome at the Central Johannesburg College (CJC): see Figure 8. A major advantage of this formwork is that it can be deflated and re-used, making it a very economical and efficient option if many similar structures are to be built. Such formwork also facilitates rapid construction; the dome at CJC was built in only two days. Furthermore, the form is very flexible, making it more accommodating to shrinkage (when compared with the more typical rigid types of formwork).

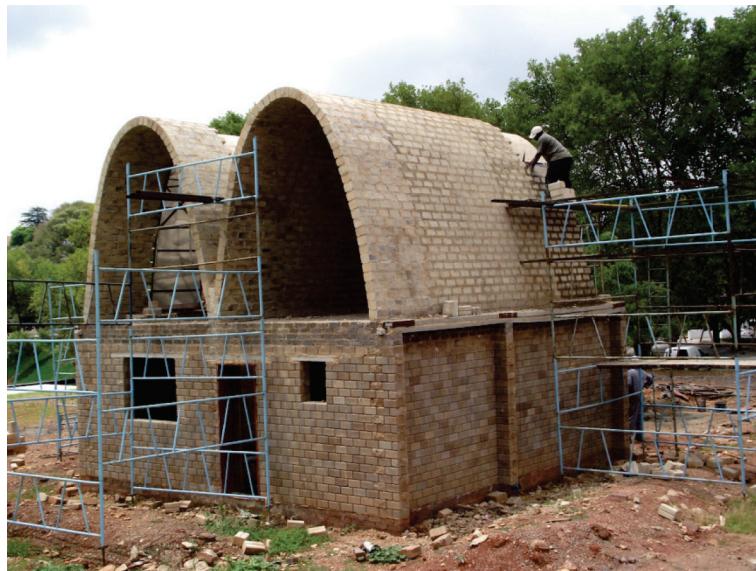
Figure 9. Construction of the Wits Shells

When adopting the sliding technique, only a small segment of formwork is used instead of continuous formwork. Construction takes place sequentially, as the formwork is shifted to create the barrel vault. The technique is relatively cheap because only a short piece of singly curved formwork needs to be manufactured. This construction technique was used to build two steep catenary vaults at the University of the Witwatersrand (Bulovic, 2014), as shown in Figure 9.

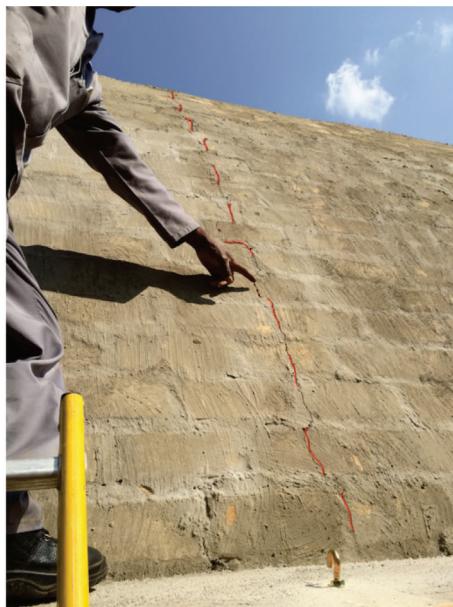
Figure 10. Crack at the Interface Location (Crack Traced in Red for Clarity)

The shifting technique is mentioned in several books (e.g., Joffroy and Guillaud, 1994; Minke, 2009) however, no information of any problems associated with this method could be found in the literature apart from Bradley et al. (2016). Bradley et al. attribute several vertical cracks, observed on the external and internal surface of two steep catenary vaults, to differential shrinkage between adjacent segments and consequently the generation of restraint. One of these cracks is shown in Figure 10.

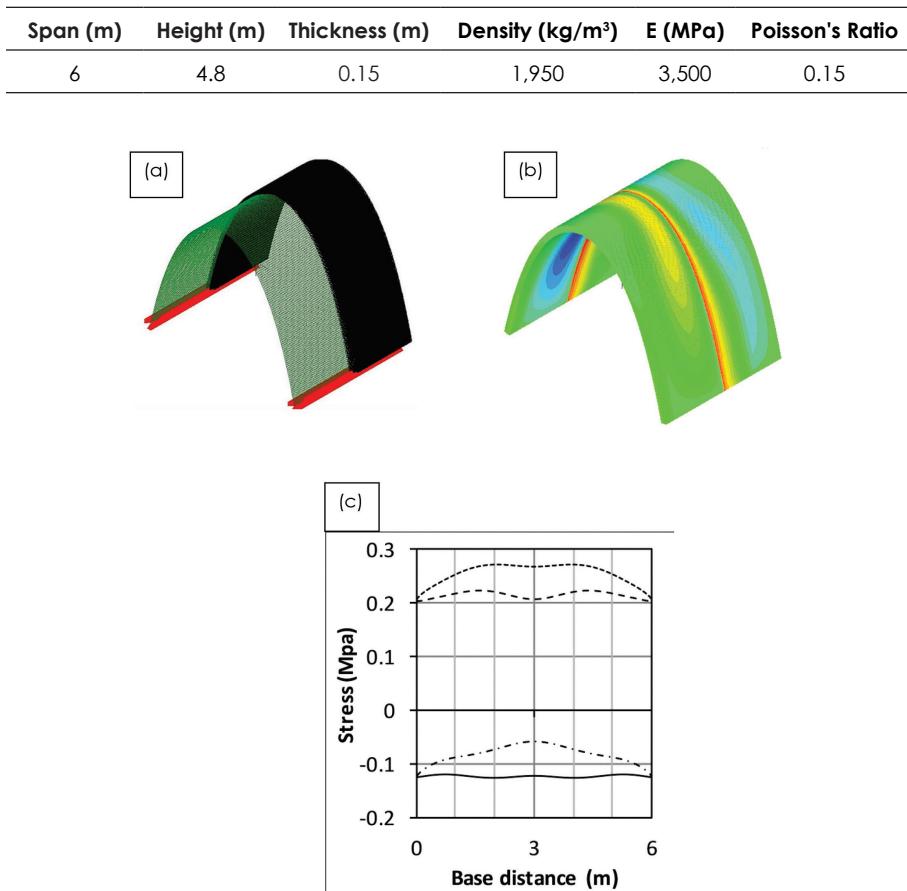
Figure 11. FE Model and Results: (a) 20°C Temperature Drop Over Half of the Structure, (b) Minor Principal Stress Upper and Lower Surface and (c) Principal Stresses: Pinned Boundary Conditions

Although the explanation for the cause of these cracks appears rational, a simple analysis using finite elements (FE) is considered for further assessment. A finite element package was used to create a model of a steep free-standing catenary vault: see Figure 11(a). Eight-node quadrilateral shell elements, and a regular/structured mesh, were utilised in the analysis. The material and geometric properties implemented in this simple assessment are shown in Table 1 (Material isotropy was assumed and the appropriate properties for CSEB were adopted from Magaia [2003]).

Initially, the element mesh was refined, for self-weight loading, until the model converged to the exact/closed-form solution. Subsequently, thermal contraction (created by applying a temperature differential to the shell) was used to simulate shrinkage. In particular, a drop in temperature was applied to one half of the shell only (as shown by the black region in Figure 11[a]); to simulate the effects of different rates of shrinkage in adjacent sections of a vault. The calculation of the temperature differential (ΔT) and coefficient of linear expansion (α), to roughly simulate shrinkage, are discussed below.

Figure 11(b) shows the internal and external minor principal stress contour plots corresponding to pinned boundary conditions. A damp-roof course (DPC), situated at the base of the shell, would engender a pin (or sliding) support. The arrows in black show the direction of these stresses at the interface. It is apparent in the plot that maximum tensile stresses, identified by warm colours (i.e., red), are localised along the interface (i.e., along the centreline). These major and minor principal stresses along the centreline of the vault are shown, for pinned boundary conditions, in Figure 11(c). This figure demonstrates that the major principal stresses are purely compressive; however, the minor principal stresses are entirely tensile at the inner and outer faces. Tensile stresses also exist when the support condition is changed to fixed (i.e., an infinitely stiff support): not shown in this paper. Although this analysis is somewhat simple, the maximum tensile stresses coincide exactly with the observed cracking in the Wits shells, which gives support to the postulate for cracking proposed by Bradley et al. (2016).
