**STRUCTURAL BEHAVIOUR OF CORROSION-DAMAGED RC
SHORT COLUMNS WRAPPED WITH HYBRID FIBRE
REINFORCED POLYMER REINFORCEMENT**

**Thesis submitted in fulfilment of the requirements for the degree of
Master of Science**

Universiti Sains Malaysia

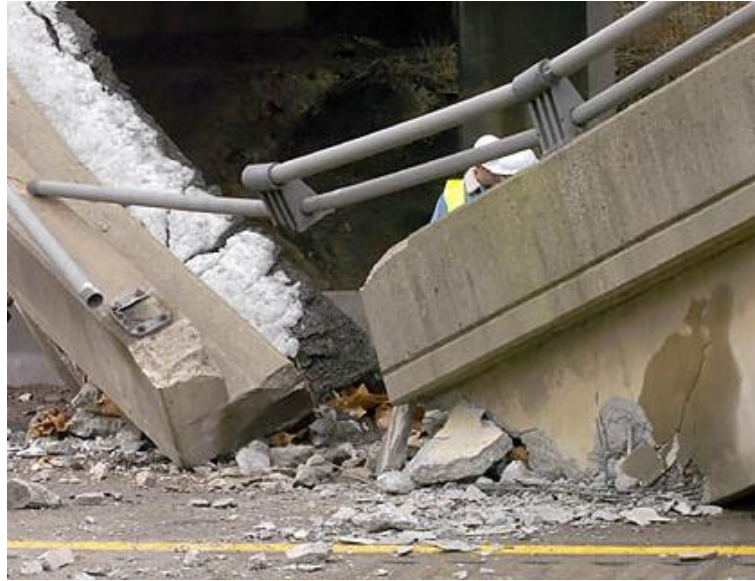
Figure 1.1: Partial collapse of the exterior girder of an overpass caused by pre-stressed reinforcement corrosion due to the application of deicing salts (Grata, 2005)

For several decades, reinforced concrete (RC) has been extensively used as an economical construction material for construction of various structures such as high rise buildings, sky scrapers, bridges, etc. These RC structures are very susceptible to corrosion attacks as these structures have been exposed to different environmental conditions. It is well known that corrosion of steel reinforcement is one of the most predominant degradation mechanisms in RC structures, which could seriously affect the serviceability and the durability of the structures. In 2005, American Society of Civil Engineers (ASCE) reported that 27.1% of America's 590,750 bridges and 31.2% of urban bridges have been categorised as either structurally deficient or functionally obsolete due to the deterioration caused by corrosion of reinforcing steel. According to ASCE, a structurally deficient bridge is one that is closed or restricted to light vehicles due to the distressed structural components. These structurally deficient bridges have not been categorised as unsafe, however must have speed and traffic load limits. Moreover, the bridges have older design features and cannot safely accommodate the current traffic volumes and sustain vehicle sizes and weights are defined as functionally obsolete (Parish, 2008). Similarly, there is an urgent need of a reliable method of bridge repair that has become even more evident in the recent years due to the highly publicized concrete bridge failures, such as the I-70 overpass near Pittsburgh, Pennsylvania, shown in Figure 1.1 which is caused by prestressed reinforcement corrosion likely due to the application of deicing salts.

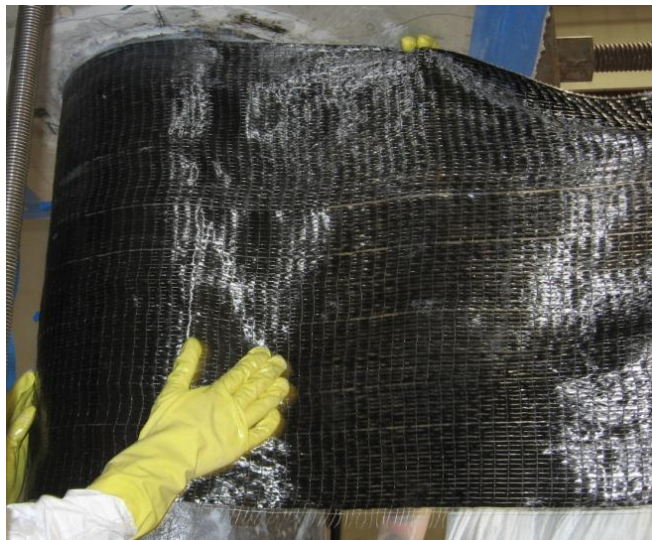
Figure 1.4: Repair of damaged bridge columns using Fibre Reinforced Polymer (http://cceer.unr.edu/projects/repair_of_bridge_columns/nhs2r.html)

Fibre reinforced polymers (FRPs) is a new composite material which have been sought by structural engineers and researchers to repair and upgrade the damaged reinforced concrete structures. The use of FRP sheets in rehabilitation of concrete structures has been effectively demonstrated in various investigations as these materials are not affected by electro-chemical deterioration and can resist corrosive effects of acids, alkalis and salts under a wide range of temperatures. Thus, unlike steel reinforcement, FRPs can be applied on the surface of concrete with little apprehension of environmental degradation. Figure 1.4 shows the repair of damaged bridge columns using FRP.

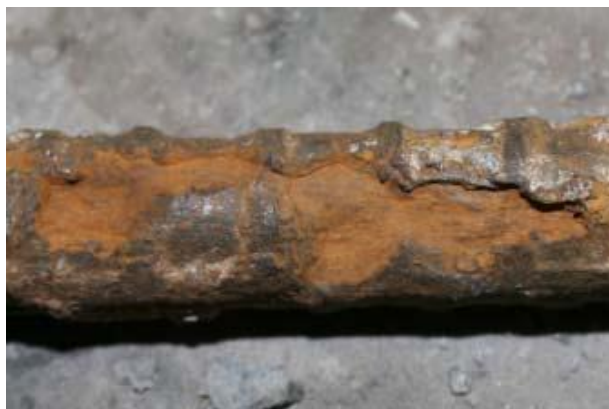
Figure 2.2: Pitting corrosion in steel reinforcing bar by chloride attack (Parish, 2008)

percolation of Cl^- present in saltwater to the level of steel reinforcing bars embedded in concrete destroys the passive oxide film on the steel in localized regions and can set a resource for active corrosion in steel reinforcement (CEB, 1992; ACI, 2005). Figure 2.2 shows the pitting corrosion of steel reinforcing bar by chloride attack.

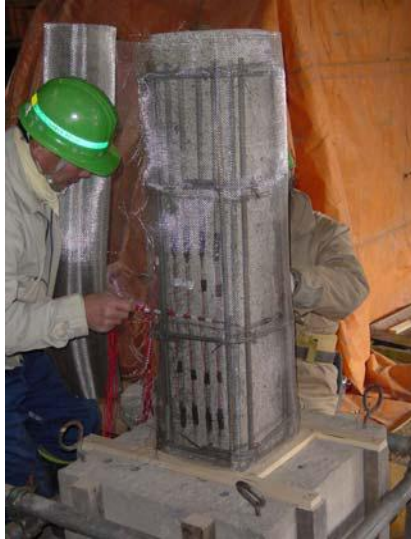
Figure 2.3: Ferrocement jacketing
(Kumar et al., 2007)

External jacketing using ferrocement is a simple method for strengthening of reinforced concrete or masonry members; it consists of light structural steel, wire mesh layers, high quality cement matrix, admixtures, super plasticizers, fibres etc. The high quality cement matrix has a ratio of 1:1.5 to 1:2.5 or so. At the outset, a layer of steel wire mesh wrapping around the column and nailed using U nails or tied around using steel wires. Subsequently, the freshly prepared cement mortar is applied through the wire mesh and adheres on to the surface of concrete substrate. The application of ferrocement jacketing is almost similar to that of plastering application (see Figures 2.3 and 2.4). It is obvious from previous studies that the use of ferrocement jacketing increased stiffness, strength, and ductility of column member. Ferrocement can be described as a modified form of reinforced concrete with elimination of coarse aggregate, large-size reinforcement, sometimes shuttering, however the properties of concrete is quite different with increased strength. As the surface of ferrocement jacketing had wire mesh layer, this wire mesh could prevents the formation of cracks at the surface of the ferrocement jacketing layer and propagates further deep into the material. Ferrocement has a crack-arrest mechanism and is a denser material as compared to the concrete with hard surface. However, this technique has some disadvantages such as structures made with ferrocement jacketing can be punctured by forceful collision with pointed objects. For corrosive environmental conditions, it is often observed that the reinforcing material might be corroded. However, this failure is always due to the incomplete coverage of the metal by mortar during construction. Moreover, it is nearly impossible to fasten objects to ferrocement with bolts or screws, because the drills usually break against the lightly covered reinforcing material. Fastening with nails or by welding is not

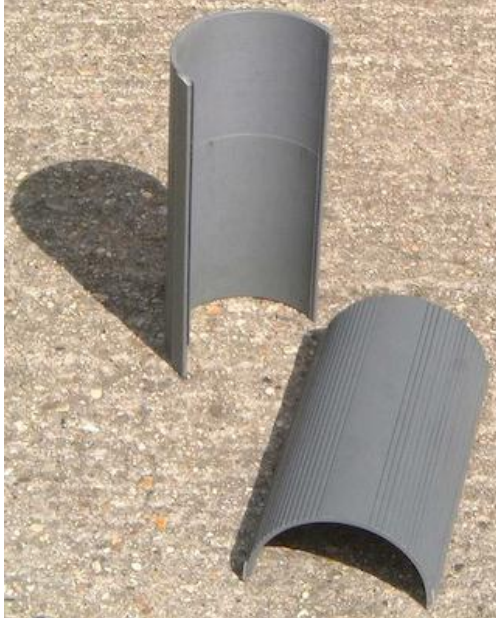
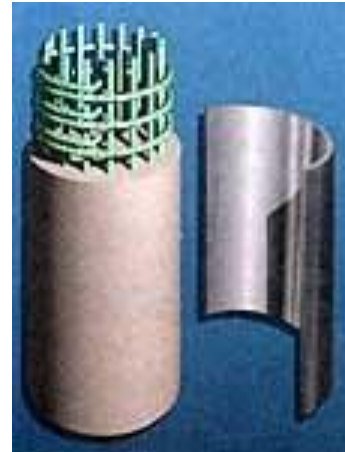
Figure 2.5: Two half shells of rolled steel plate Figure 2.6: Steel plate around column
(<http://www.johnwilkinsonltd.com/road-safety/stirmex.html>)

The most common retrofitting technique used is steel jacketing, which apply in conjunction with epoxy-bonded or grout-bonded steel plates on the surface of concrete. For instance, the cross section of column member is circular, two half shells of steel plate rolled to a radius of 12.5 to 25 mm larger than the column radius are positioned over the area to be retrofitted and are site-welded up the vertical ridge to provide a continuous tube with a small gap around the column. This gap is grouted with a pure cement grout, after flushing with water (Xiao et al., 1993). Figures 2.5 and 2.6 show the two half shells of steel plates and steel plate enveloped around the column, respectively. This method has a significant effect on increasing of load-resistance capacity and improving performance of the structures. However, the steel plates have a stability problem because the steel jacket can be easily damaged by marine environments and de-icing salts. Hence, they are vulnerable to

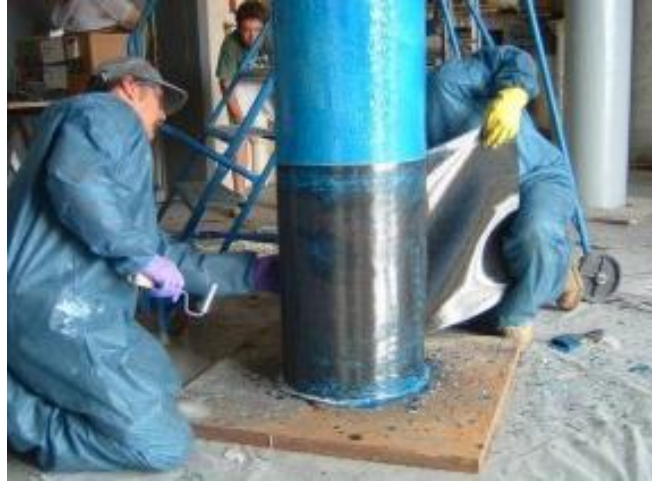
Figure 2.7: Installation of FRP reinforcement
(<http://www.compositesmanufacturingblog.com>)

degradation. Figure 2.7 shows the installation of FRP reinforcement. The details of FRP application procedure are discussed in Chapter 3.
