**EVALUATION OF STRUCTURAL POUNDING BETWEEN
ADJACENT BUILDINGS SUBJECTED TO REPEATED
GROUND MOTIONS**

This dissertation is submitted to

UNIVERSITI SAINS MALAYSIA

MASTER OF SCIENCE

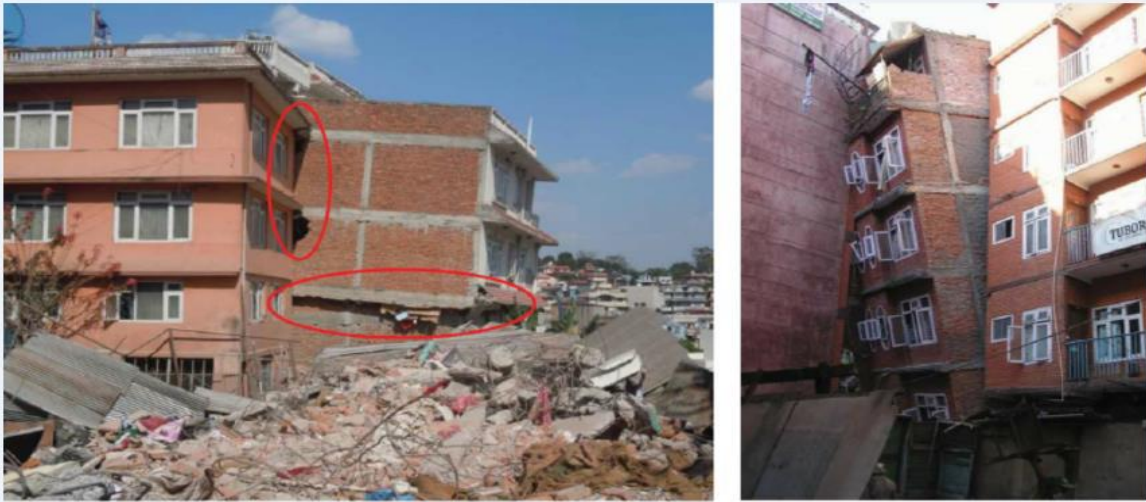
Figure 1.1: Collapse of intermediate stories due to pounding of adjacent buildings (Rai et al., 2016)

The structural pounding is the collision of neighboring buildings under long-period ground motions due to the insufficient gap (space) between the two buildings as shown in Figures 1.1 and 1.2.

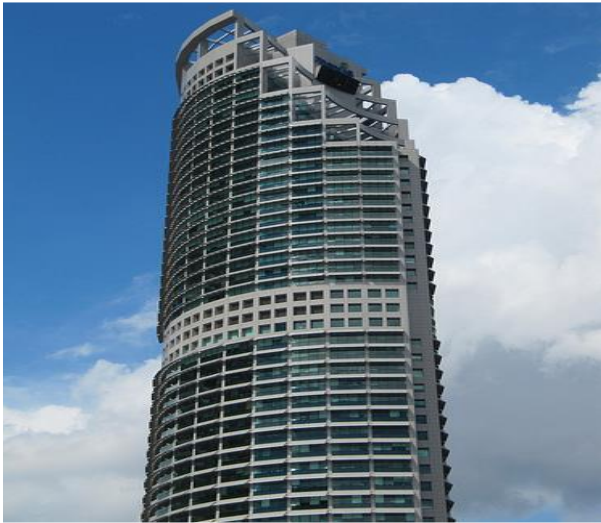
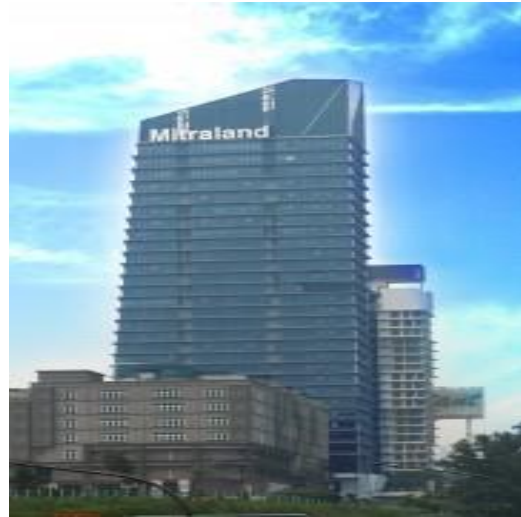
(a) Maxis tower

(b) Mitraland building

Figure 1.3: Irregular structures

The damage in the structure and the pounding phenomena are enhanced or suppressed by several factors mainly the intensity of the ground motion, the regularity/irregularity condition of the structure and the gap between the structures. Figure 1.3 shows examples of irregular structures while Figure 1.4 shows examples of the gap between the structures.

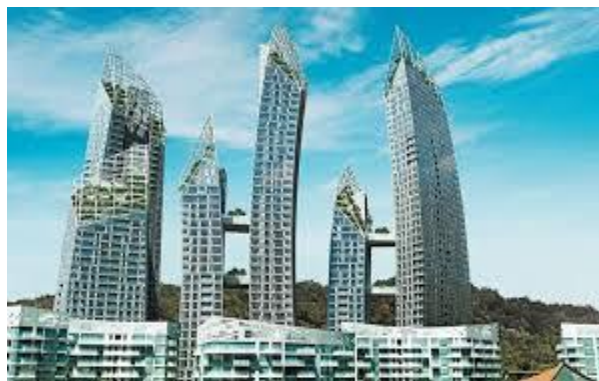
Figure 1.4: Contact and spaced structures
