FIRE-DAMAGED NORMAL CONCRETE
PROPERTIES AND BOND STRENGTH
EVALUATION OF ULTRA HIGH PERFORMANCE
FIBRE REINFORCED CONCRETE AS A REPAIR
MATERIAL

UNIVERSITI SAINS MALAYSIA

2017

Thesis submitted in fulfilment of
the requirements for the degree of
Master of Science

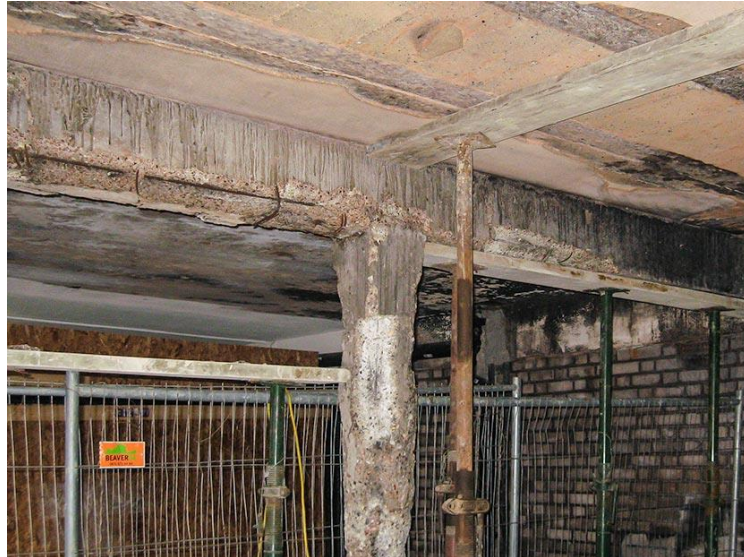
One of the advantages of concrete over other building materials is its inherent fire-resistance properties. However, it is important to design the concrete structures for fire. Structural components need to withstand dead and impose loads without collapse even though there is decrease in strength and modulus of elasticity due to high temperature. In addition, heat will caused structural component expansion. Furthermore, if reinforced concrete (RC) buildings exposed to accidental, their major component such as columns, beams and slabs will crack, spall and loss in the bearing capacity. Figure 1.1 shows the spalling of concrete beam and column.

Figure 1.1 Spalling of concrete to beam and a column caused by fire

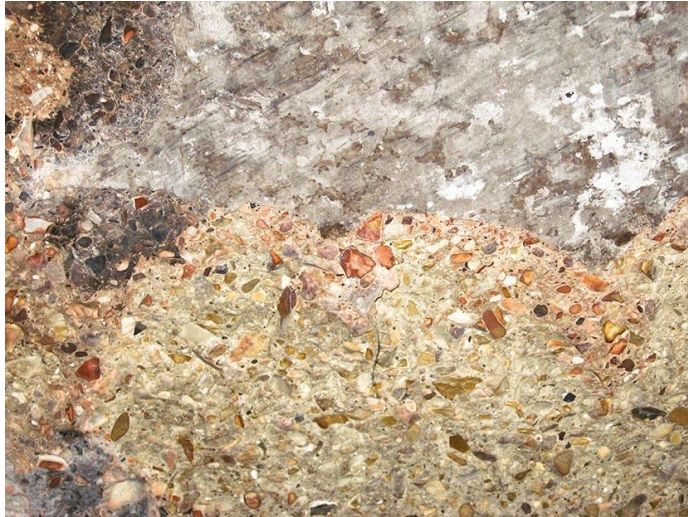
Concrete's colour changes may indicate the exposure to temperatures greater than 550°C. Concrete that subjected to temperatures higher than approximately 570 °C usually turns to pink, associated with chemical changes of the iron-containing compounds in the aggregates and paste matrix. Concrete that has turned pink is considered as damaged and should be replaced and repaired (Marxhausen, 2014). Figure 2.2 shows concrete spall from slab soffit and pink/red discoloration.

Figure 2.2 Concrete spalled from slab soffit showing pink/red discoloration (Rogerson, 2017)

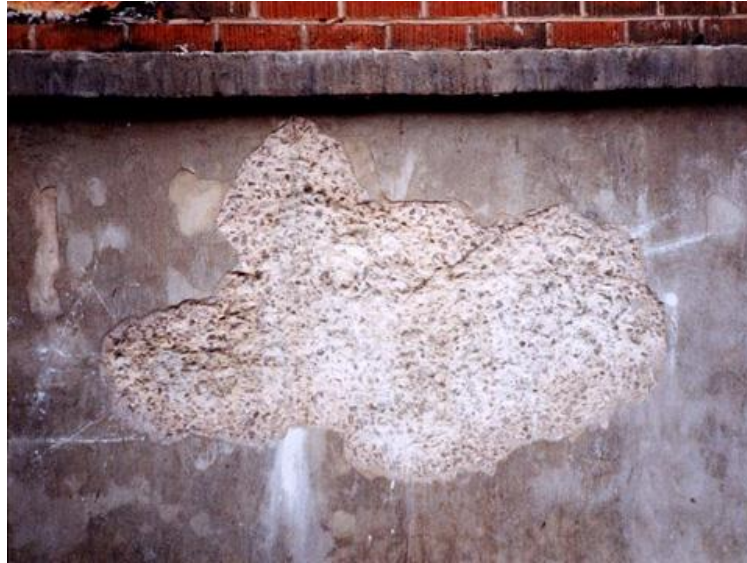
Previously, Sarker et al. (2014) stated that, concrete starts to spall at 800 °C and 1000 °C temperatures. The pieces of concrete spalled without any explosive sound. Spalling occurred cause by the thermal gradient between concrete internal core and its surface. This is due to the temperature of furnace air which accelerated quickly. The image of concrete spalling is shown in Figure 2.3.

Figure 2.3 Concrete spalling on wall (Rogerson,2017)

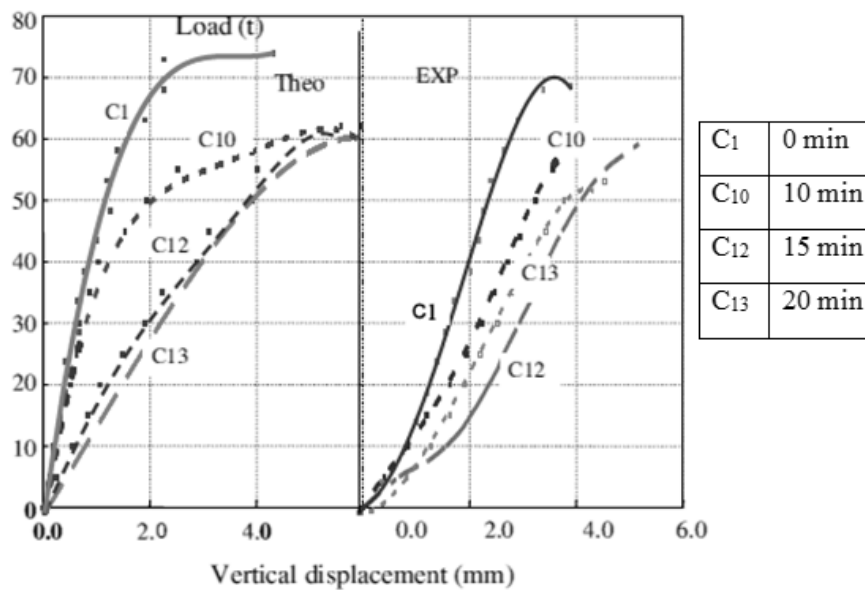
Both experimental and theoretical analysis reported that as the period of fire increases, the column stiffness decreases. The analysis also showed that with increase in the period of fire (10, 15, 20 min), the corresponding column failure load compared with C₁ decreased by nearly (12%, 15%, 25%) respectively, as shown in Figure 2.4

Figure 2.4 Experimental and theoretical load-vertical displacement relationship (Bikhiet et al., 2014)

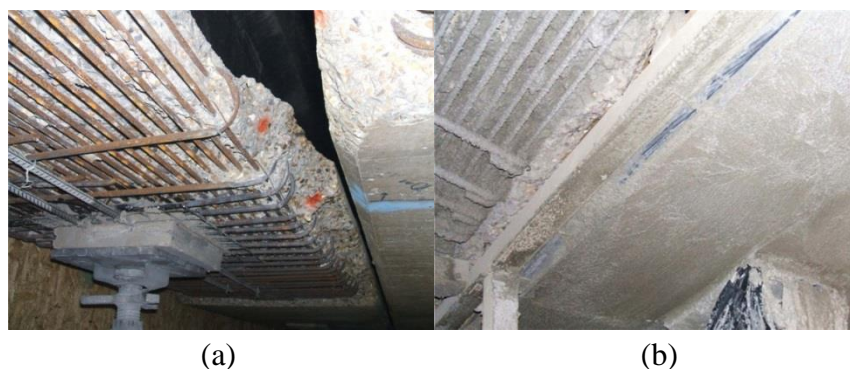
A while ago, retrofitting work for fire-damaged structures involved normal concrete only. For example, fire-damaged St Elizabeth hospital was repaired with shotcrete and epoxy injection. In April 2011 Dean's Brook Viaduct at London repaired by sprayed concrete reinforced with wire (Wheatley et al., 2014). Figure 2.5 shows before and after repair work of fire-damaged structures.

Figure 2.5 Before (a) and after (b) photo of Dean's Brook Viaduct repair work (Wheatley et al., 2014)
