EXPERIMENTAL INVESTIGATION ON THE LOAD  
CARRYING CAPACITY OF MODIFIED PURLIN TO  
RAFTER CONNECTION

SCHOOL OF CIVIL ENGINEERING  
UNIVERSITI SAINS MALAYSIA  
2017

**BACHELOR OF ENGINEERING (HONS.)  
(CIVIL ENGINEERING)**

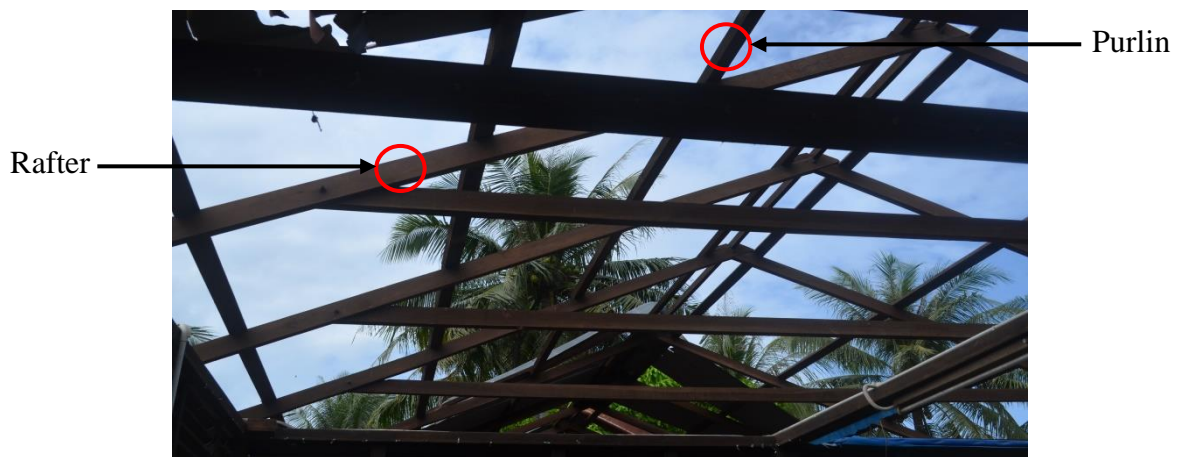
A roofing system consists mainly of two parts namely the cladding and the internal support structure. The amount of load that the internal support structure can carry without the roof collapsing is defined as the load bearing capacity (FEMA, 1993). The strength of the internal support structure must be able to sustain not only the roof cladding materials but also objects that sit on top of the roof such as solar panel, small water tank, ceiling and etc. One type of the internal support structure is the roof truss system as shown in Figure 1.1.

Figure 1.1: Timber roof truss

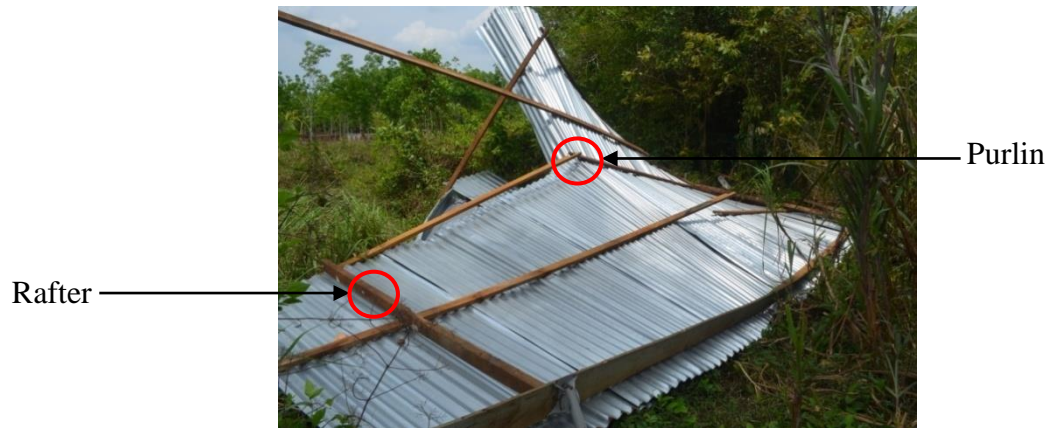
During strong wind events, roofing system of low-rise buildings can be very susceptible to damage (Uematsu et al., 1999; Holmes, 2001). This phenomenon becomes critical for the roofing system of rural houses (low-rise non-engineered buildings) due to the lack of engineering considerations (Zaini et al., 2017). Figure 1.2 shows an example of a severely damage roofing system of a rural house in Baling, Malaysia.

Figure 1.2: Total roof blown-off

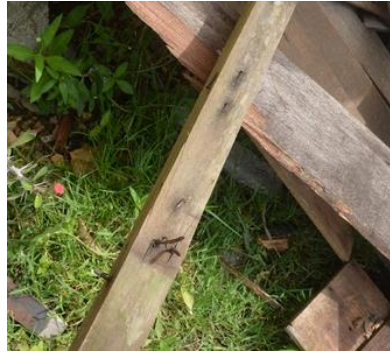
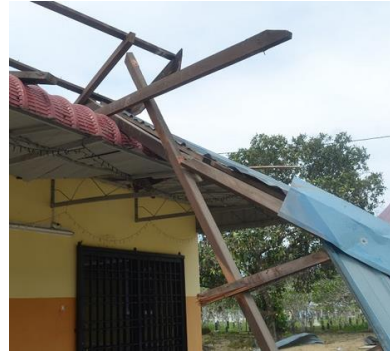
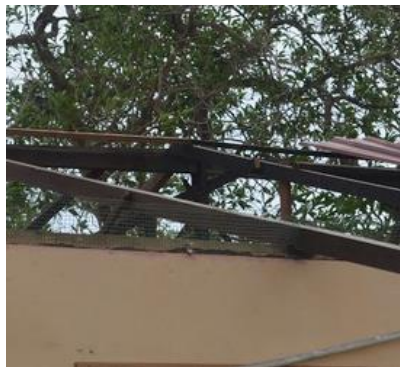
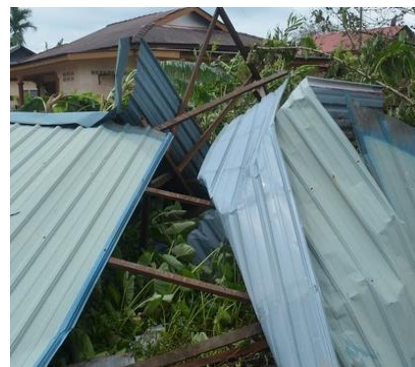
Figure 1.3: Types of failure for timber roofing system showing (a) purlin dislocated from rafter (b) severely damage rafter (c) partially blow-off roofing material and (d) total roofing system dislocated from rural house

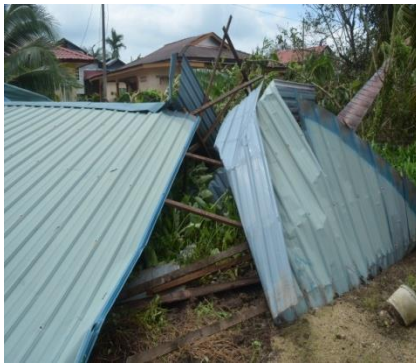
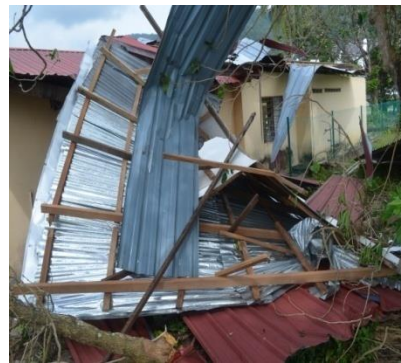
There were many events pertaining to wind related disaster that has been recorded in Malaysia (Ramli et al., 2011; Low, 2006). These incidents can occur either in urban or rural areas. In rural areas, the major damage occurred due to the lack of concern regarding the wind effect to the houses and this event rise through the nation. From the earlier study carried out, it was found that that most of the failure occurred at the roof and truss system of the house (Majid et al., 2016).The uplifting of roof in the rural areas caused losses in term of money and threat to human lives. Figure 2.1 shows the uplifting of roof during a strong wind storm event in rural areas.

Figure 2.1: Photo (a) and (b) show the uplifting and total roof blown that carry potential hazard to human life

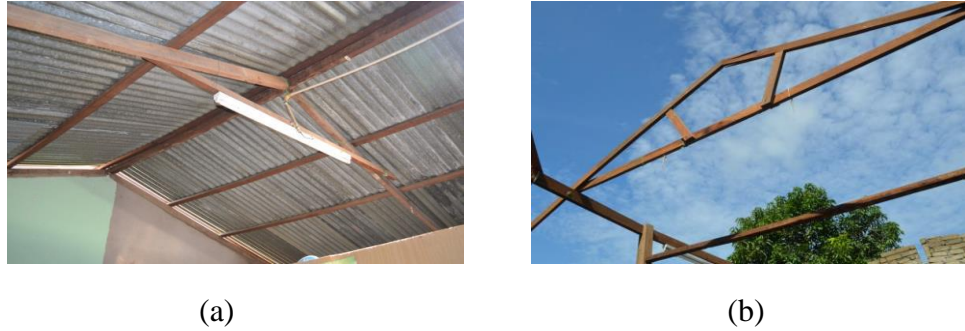
The main issue for the construction of rural house is the cost (Bakhtyar et al., 2013) and it includes the roofing system as well. Low strength timber trusses were widely used in rural area in Malaysia because it is much cheaper than other trusses such as steel or aluminium. Most of the timber trusses in rural area were built based only on labours experience and skill. Figure 2.2 shows the simple trusses for non-engineered buildings in rural area which consist series of purlin set on top of rafter and covered by roof sheeting.

Figure 2.2: View of timber truss system for non – engineered building in rural area showing (a) complete roofing system and (b) bare timber frame (Majid et al., 2016)
