**CONTINGENCY PLAN FOR MANAGING SLOPE-
RELATED RISKS: A CASE STUDY FOR MENORA
TUNNEL IN MALAYSIA**

**SCHOOL OF CIVIL ENGINEERING
UNIVERSITI SAINS MALAYSIA
2018**

**BACHELOR OF ENGINEERING (HONS.)
(CIVIL ENGINEERING)**

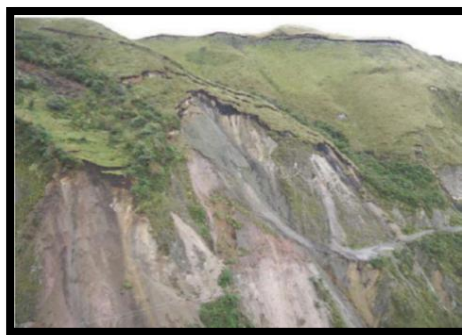
In September 2011, a landslide occurred due to a large scale of slope failure occurring parallel and adjacent to the end stretch of the headrace tunnel with about 300m of the 5.5 km long. Associated to geological damages, the affected area has cut off the normal operation of the plant (Micheli et al., 2013). Therefore, in result of damaging, the plant had to be closed after 34 years of operation and classified that slope failure is the major risk of the disaster event that happen on the highway tunnelling project in Ecuador.

Figure 2.1: Landslide that affected the Pucara Headrace Tunnel.

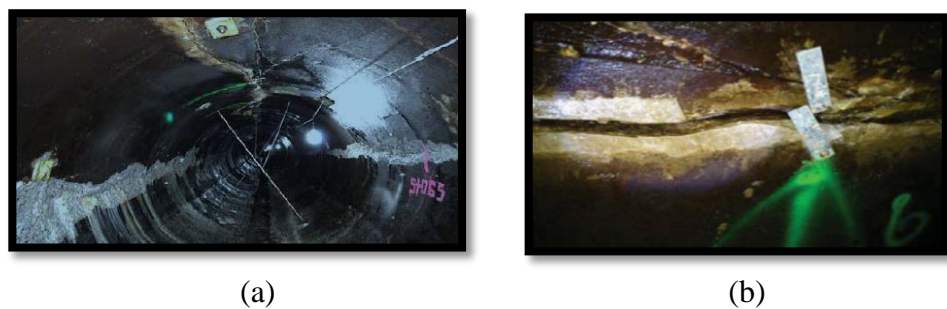
However, the plant was stopped due to the presence of concrete debris in the turbines. During an inspection of the headrace tunnel, there are a series of cracks and damages occurred in the concrete lining of the tunnel reinforced with steel bars (Lee et al. 2017). This situation affected the condition of the tunnel itself. From the report, the stretch was affected by the damages of crossing by geological fault.

Figure 2.2: Pucara Headrace Tunnel (a) stretch of damaged and (b) fracture detail

In addition, the persistent cracking propagation has seriously resulted in damage effects to the curvature impact on the concrete lining of the tunnel. A compression of both semi-circumferential concrete parts happened which has developed the maximal compressive stress resulting the rock spalling at the tunnel roof (Micheli et al., 2013). The ancient slides over the tunnel stretch which was affected by damages, actually influenced the slope stability.

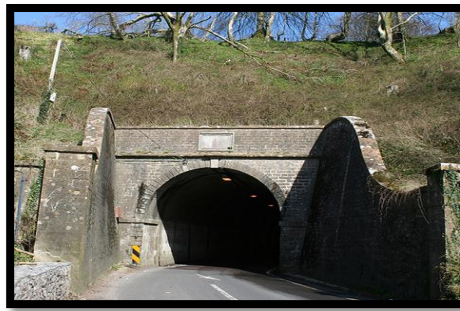
Beaminster Tunnel or Horn Hill Tunnel as shown in figure 2.2 is a 105m length road tunnel on road between Beaminster and Mosterton in Dorset, England. It is well-known for being the first road tunnels built in Britain and the only pre-railway road tunnel in the country can still be used. The tunnel was built to take a toll road underneath a steep hill to the north of Beaminster and make it easier for horse-drawn traffic to travel from the coast to the interior of Dorset.

Figure 2.3: Beaminster Tunnel or Horn Hill Tunnel located in England.

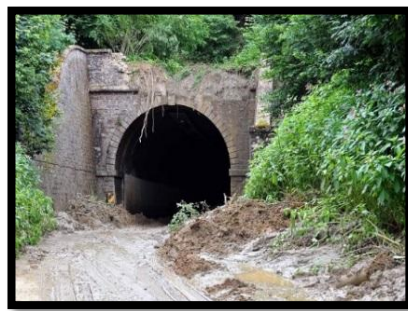
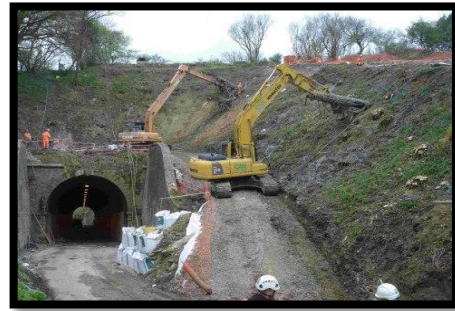
Furthermore, due to damages occur as shown below in figure 2.4 (a), significant repair work as figure (b) was done to strengthen the structure of the soil. From now until the opening day the remaining work will be completed. This includes connecting the drains drilled deep into the hillside to the drains that go behind the retaining walls on the approaches, removing the temporary ramps that provided access for work above the tunnel, reinstating and testing the lighting on the approach and in the tunnel, and resurfacing the road on the approaches and within the tunnel (Andrew et al., 2010).

Figure 2.4: (a) Slope failures caused landslides and (b) significant repairs.

The tunnel will be closed for some period of time to undergo significant repairs in 1968 and again in 2009 for the rehabilitation and maintenance work of tunnel. The walls at both ends have been protected with additional concrete walls constructed behind them and the walls on the approaches have been stabilised. Finally, after significant repair, Beaminster Tunnel are open a year after tragedy.

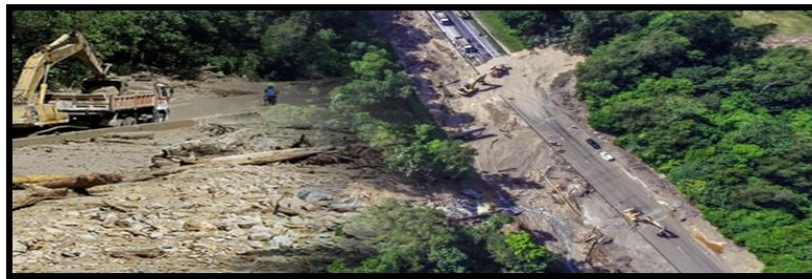
Recently, on 11th November 2015, a landslide occurred at km 52.4km of the Kuala Lumpur-Karak Expressway between Lentang and Bukit Tinggi, Pahang and Gombak-Bentong old roads as shown in Figure 2.5. The tragedy has blocked all lanes in both directions on the Karak Highway in Malaysia. There are some cars are buried in during the landslide. Luckily there are no casualties reported during this incident.

Figure 2.5: Landslide at Kuala Lumpur-Karak Expressway.

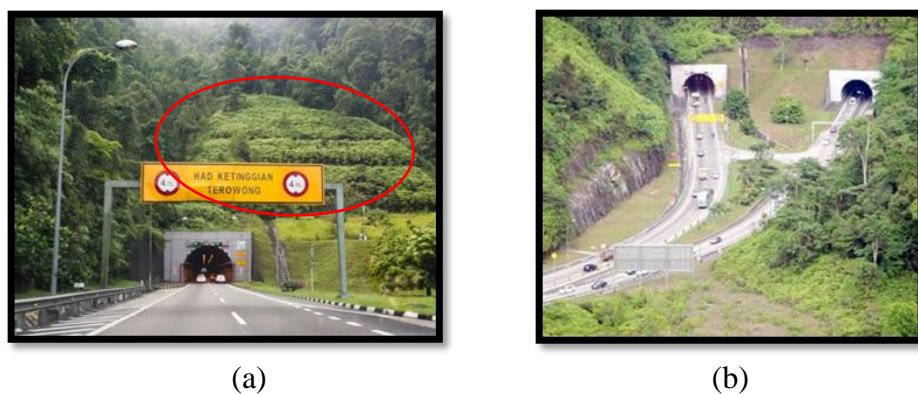
Figure 2.7: Menora Tunnel located (a) at hill area with (b) two-lane highway near Jelapang, Perak, Malaysia
