Restoration of Obliterated Stamped Marks on Cast Iron Surfaces by Etching Techniques

**Dissertation submitted in partial fulfillment for the Degree of Bachelor of
Science in Forensic Science**

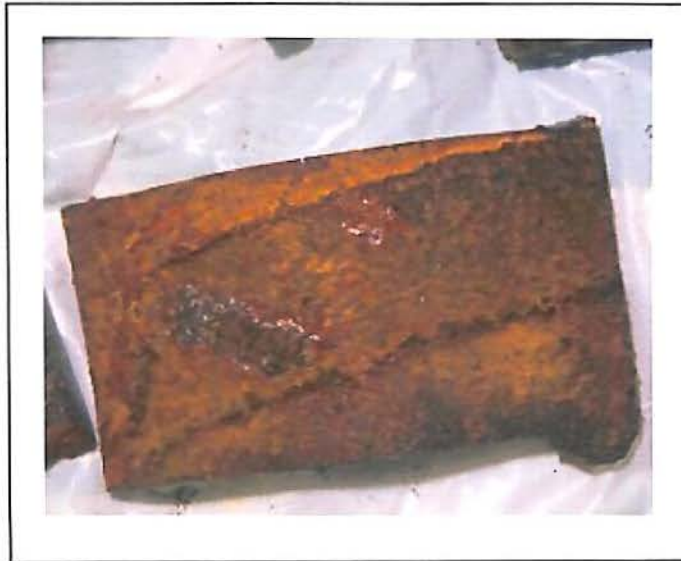
Figure 1: Original rusty cast iron plate

One cast iron engine block of Proton Saga car was purchased for this work. The engine block was cut into several small plates which were approximately about the same in size. The surface of the plate was polished with grinding machine to remove rust caused by oxidation of the iron and also to give a smooth surface. After polishing, the engine block was cleaned and cleared from grease, oil and other foreign particles using detergent and acetone.

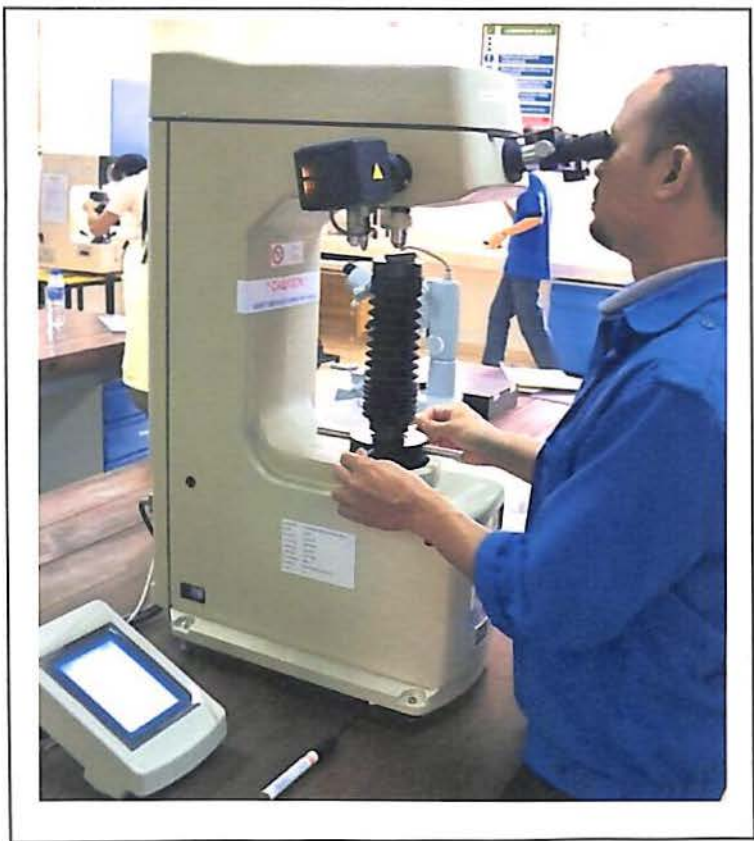
Figure 2: Hardness Testing Machine used for testing hardness of cast iron sample.

A sample of the engine metal was sent to professional laboratory in India for analysis and it was found that it was containing 3.29% carbon content. Besides that, a sample of this engine was also analyzed in the School of Mechanical Engineering, Engineering Campus, USM, Penang for measurement of its hardness by using Hardness Testing Machine. Their hardness value was found to be 213.6 Hardness Vickers (HV).

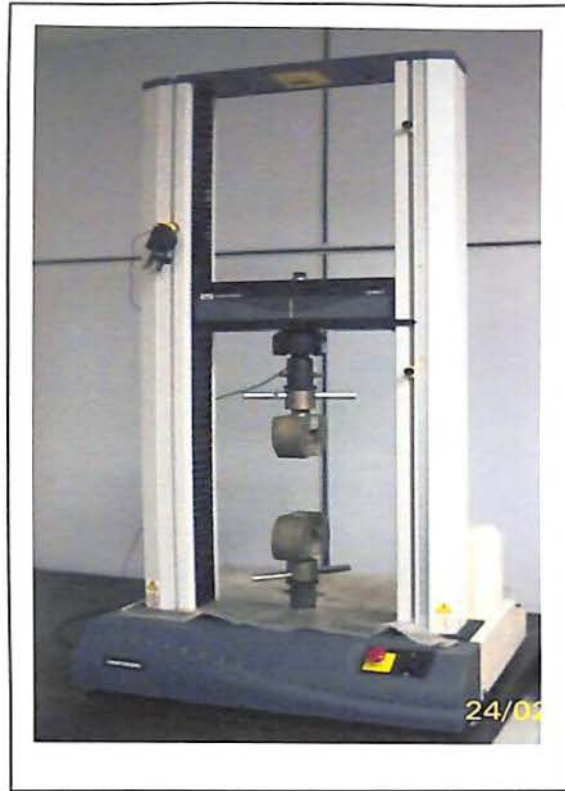
Figure 3: Instron Table Mounted Universal Testing Machine used for stamping numbers on cast iron sample. (School of Mechanical Engineering, Engineering Campus, USM, Penang)

The cast iron plates that had been cut from the car engine were used as the sample plates. A large number of these plates were then stamped with numerical characters “18” number punch by using a computerized mechanical compression machine Instron Table Mounted Universal Testing Machine, model 3367. The Hunter brand number punch size 7mm was used. Their hardness value was 592.6 HV. The number punch was compressed three times onto each plate by using 8kN load. The characters “18” were chosen, as they contained both straight and curved surfaces. The plates were then labelled appropriately with specific marks for easy identification, since each of plate would be treated with a different etching reagent.
