**INVESTIGATION ON THE EFFECT OF DRY TURNING
ON AISI 305 STEEL WITH CERAMIC INSERTS BY
ANALYSIS OF WORKPIECE SURFACE PROFILE**

This dissertation is submitted to

Universiti Sains Malaysia

BACHELOR OF ENGINEERING

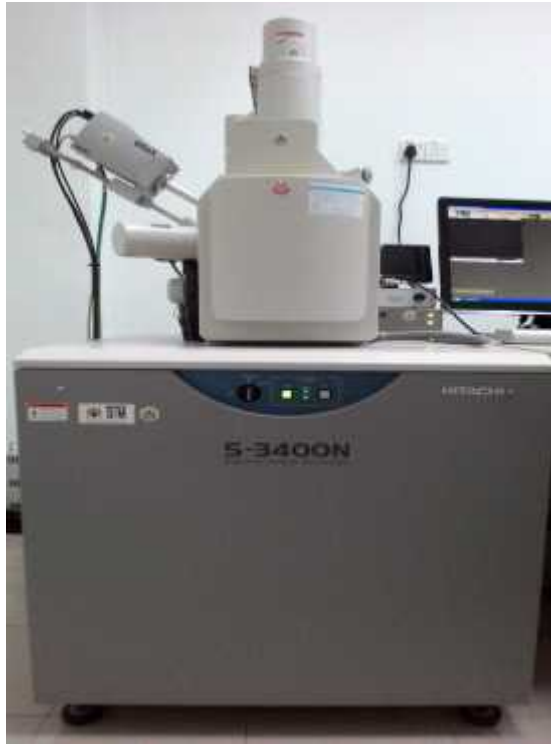
Figure 3.2 Scanning Electron Microscope (SEM), Hitachi TM1000

The cutting tool used is ceramic material with rhombus shape by Sandvik Coromant Ltd., Sweden. A ceramic insert was mounted on a Sandvik tool holder with cutting tool edge angle 80° . Before carrying out dry turning, the image of ceramic insert was captured under Scanning Electron Microscope (SEM), Hitachi TM1000 SEM as shown in Figure 3.2. Besides, the observation on the cutting tool after each pass of machining also required to detect the wear of insert.

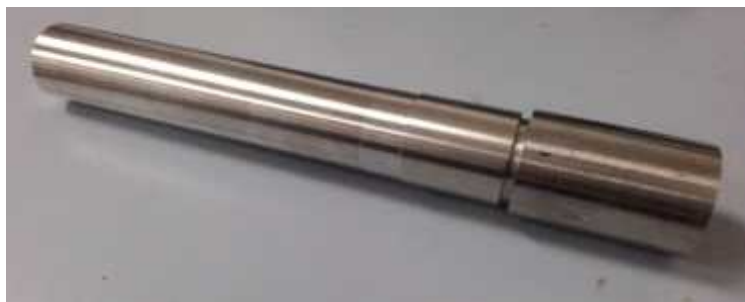
Figure 3.3 Image of workpiece

The workpiece material evaluated in this study is AISI 305 Stainless Steel. Figure 3.3 shows the image of workpiece.

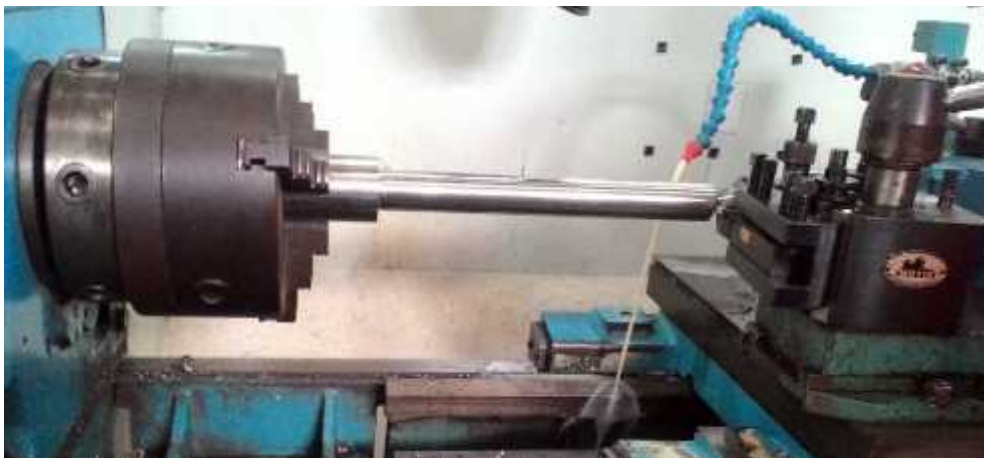
Figure 3.4 Image of wet straight turning

The performance of ceramic insert was evaluated in dry turning which no lubricant are used as a future green machining. Dry turning operation test was performed on a Pinocho S90 conventional lathe machine to study the effect of dry turning by adopting ceramic as cutting tool. Before starts machining according the desired parameter, one pass of straight turning with application of lubricant is required to clean the surface of material to obtain a smooth surface using carbide insert. Figure 3.4 shows the image of wet straight turning passes. The purpose of applying lubricant is to remove burr, chip, contamination, maximize the cutting tool life and to obtain a fine surface finish.

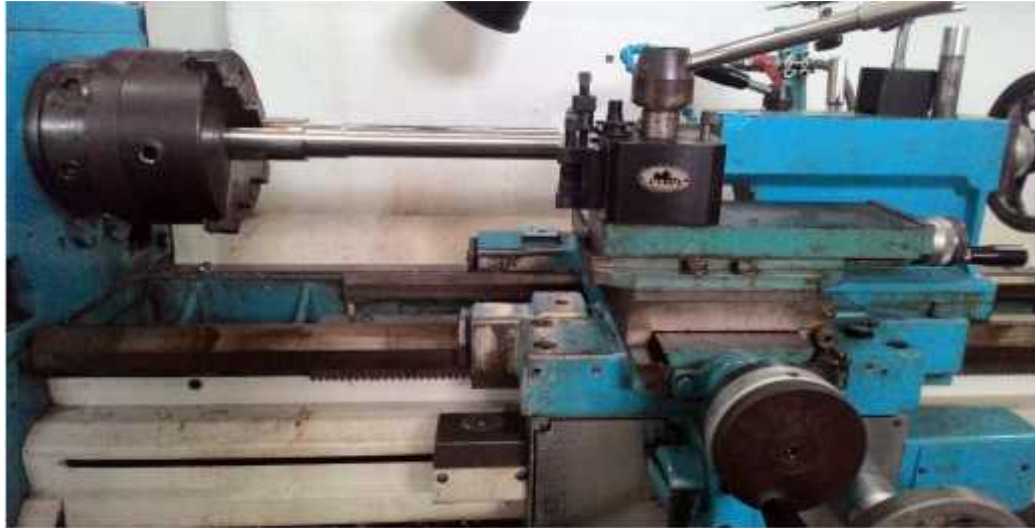
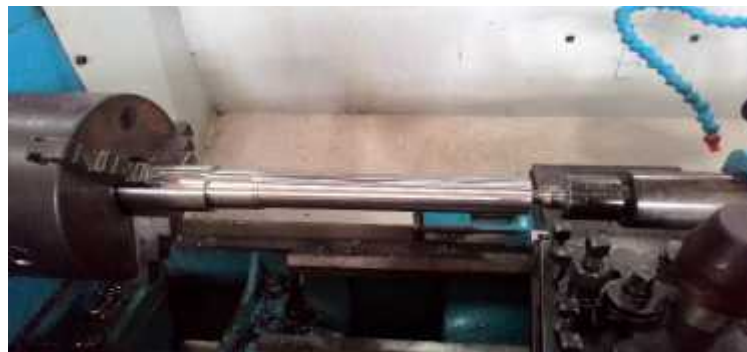
Figure 3.5 Image of machine set up (a) Pinocho S90 conventional lathe machine b)

Close view of conventional lathe machine

The image of machine set up is shown in Figure 3.5 (a) and (b). The experimented works consisted of fifth passes using same cutting tool, specimen and parameter which is cutting speed, 1400 rpm, feed rate, 0.4 mm/rev and the depth of cut is 1 mm. The continuous machining was done to observe the tool failure in machining.

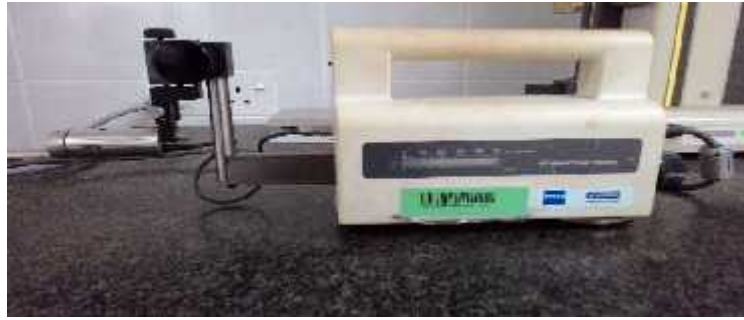
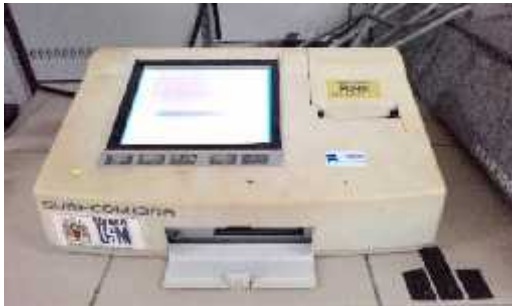
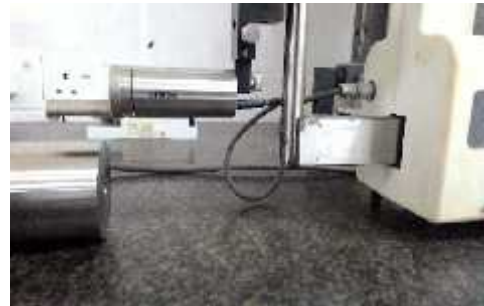
Figure 3.8 (a) Image of SURFCOM-130A (b) Data Processor (c) Image of measured workpiece

The profile of machined workpiece was compared by using machine vision and stylus method. Stylus method is measured using SURFCOM-130A Surface and Roughness Tester machine. Practically, machine vision method is the most accurate measurement compared to stylus method because the stylus have edge radius, thus it cannot measured the workpiece surface accurately. The Standard Operation Procedure (SOP) was listed in Figure 3.7. The image of Surface and Roughness Tester machine as shown in Figure 3.8 (a), (b), and (c)

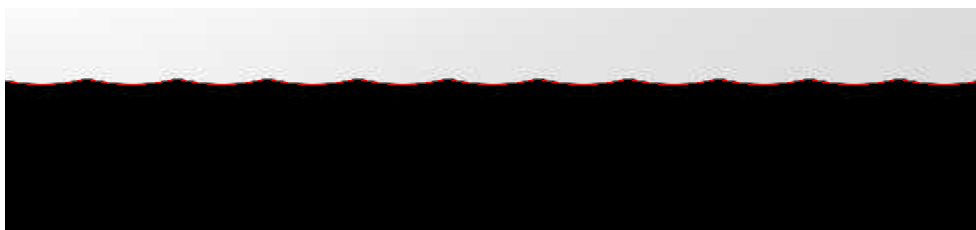
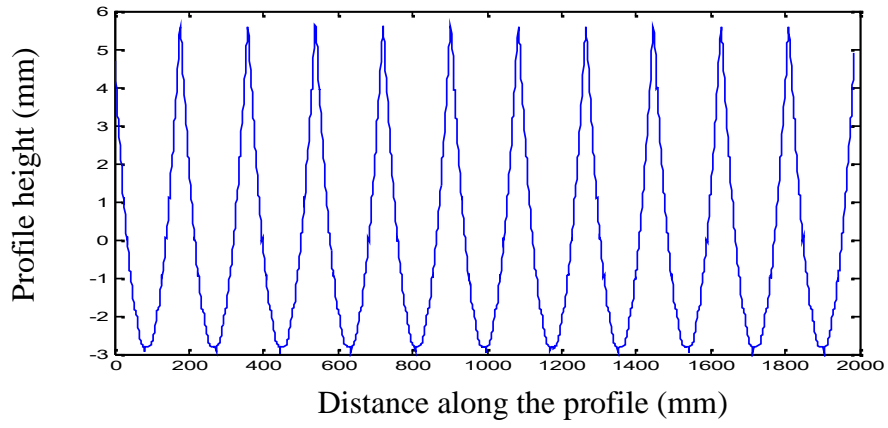
Figure 3.9 (a), (b), (c) and (d) show the theoretical surface profile analysis. The workpiece profile was designated from SolidWorks 2014x64 edition software to represent the theoretical profile of a machined surface. In theory, the peaks of ACF profile will decrease uniformly and linearly as lag distance increases due to the periodic workpiece surface profile.

Figure 3.9 Theoretical surface profile analysis (a) Image after binarize (b) Extracted profile (c) ACF profile (d) ACF graph

Based on the Figure 3.9 (a), the image of workpiece was captured under DSLR camera before extracted the image into the MATLAB programming. The presence of noise, vibration and contamination will lead to low image quality.

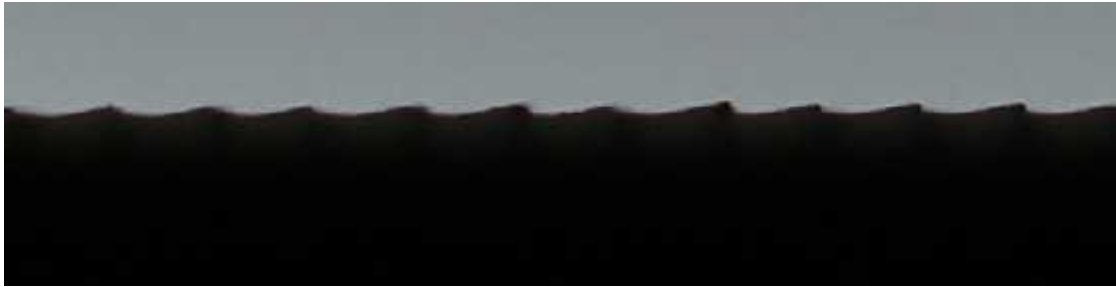
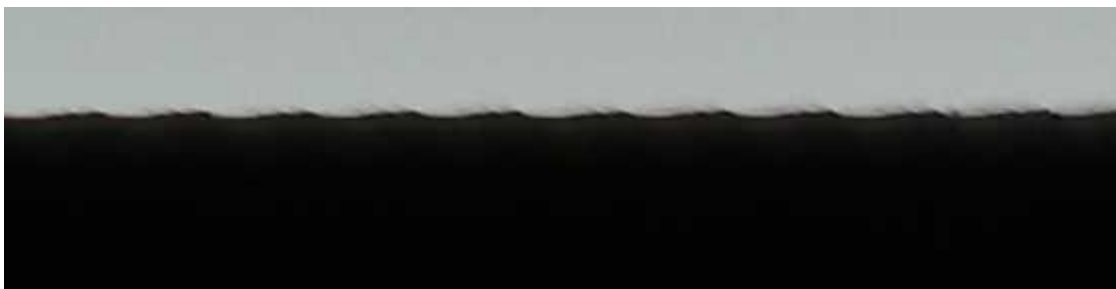
Figure 4.1 Workpiece surface profile (a) After first machining (b) After fourth machining (c) After fifth machining

The experiment was done using cutting speed, 1400 rpm with feed rate, 0.3 mm/rev and depth of cut is 1 mm. The reason used for high cutting speed is to obtain a faster wear of cutting tool after a few passes. Same goes to depth of cut, which feeds 1 mm diameter of the workpiece material is to access a tool failure. Besides, the higher feed rate per revolution is adopted to get more helical configuration of workpiece profile like the screw thread, thus the surface profile of workpiece will simply be examined. Figure 4.1 (a) and (b) shown the image of workpiece surface. Figure (a) is the image of the workpiece surface after undergo first machining, figure (b) is the surface image of forth passes and figure (c) is image of workpiece after fifth passes. Based on the figure below, figure (a) posses to fine surface profile which indicated the cutting tool is new compared to figure (b), the surface image is slowly damage after a few passes of machining which demonstrate that the tool starts to wear gradually. For the figure (c), the surface profile is slightly missing due to the tool wear.

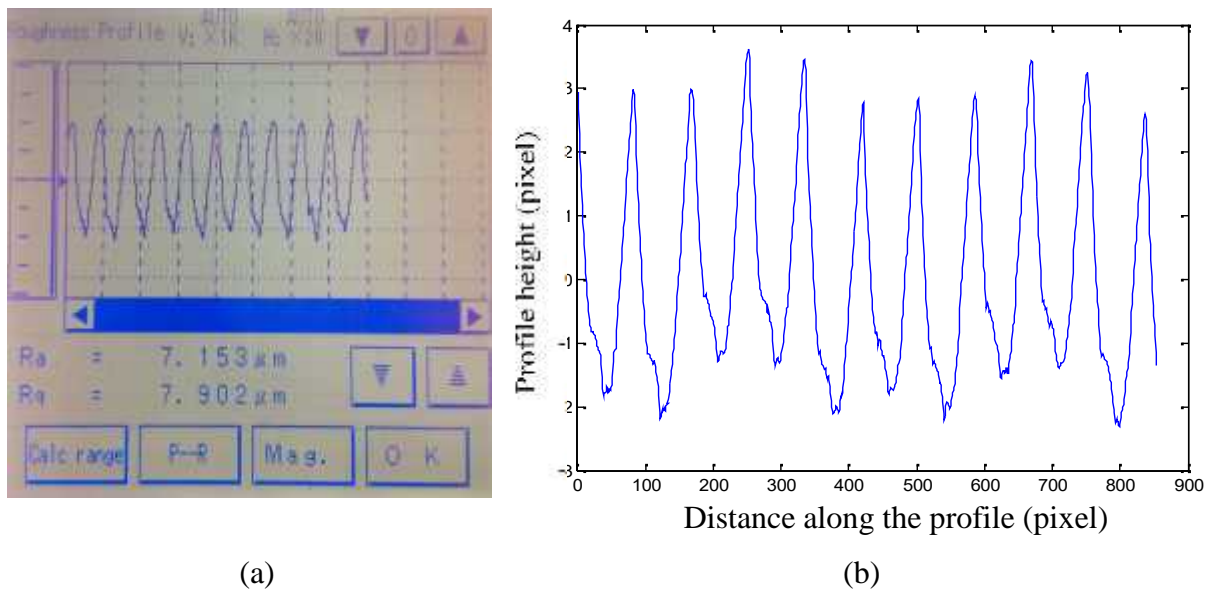
A measurement of the workpiece profile will be verified using stylus and vision method. Basically, the stylus method works by travelling along the workpiece surface. The image of the workpiece surface measurement as shown in Figure 4.5.

Figure 4.5 (a) Stylus method (b) Vision method

According to the Figure 4.5 (a) and (b), the image of the surface workpiece roughness is almost equivalent to each other. Practically, the vision method is the most accurate method in measuring the surface roughness profile compared to stylus because a stylus have edge of radius, thus it cannot measured an accurate workpiece profile.
