**CHARACTERISING MICRO-CRACKS IN
CRYSTALLINE SILICON SOLAR CELLS USING
TRANSFLECTION IMAGING**

TEO TEOW WEE

UNIVERSITI SAINS MALAYSIA

**Thesis submitted in fulfilment of the requirements
for the degree of
Doctor of Philosophy**

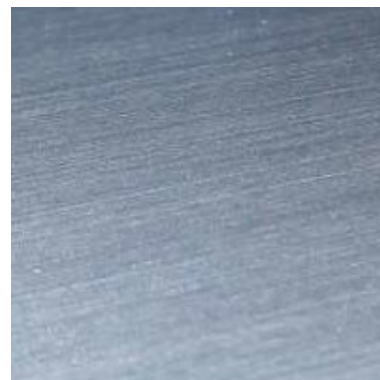
(a) Slurry wire-sawn wafer

(b) Diamond wire-sawn wafer

Figure 1.3: Cropped images of slurry wire-sawn and diamond wire-sawn monocrystalline silicon wafers showing the absence and presence of saw marks respectively.

In recent years, the slurry wire-sawing technique to produce silicon wafers are being gradually replaced by a new sawing technique in the form of diamond-plated wire-sawing (Tso, Yan, & Lo, 2006; Watanabe et al., 2010). In this new technique, the same saw as slurry wire-sawing is used, however the steel wire is replaced by a type of wire containing diamond particles and the abrasive slurry is replaced by a cooling liquid (Bidiville, Wasmer, Kraft, & Ballif, 2009). As the abrasive particles are bound to the wire instead of the slurry, diamond wire-sawing is much faster and has a lower wire wearing rate. This sawing technique also results in lower kerf loss and is regarded to be a more environmentally friendly method (Kumar & Melkote, 2018). The diamond wire-sawing technique however produces silicon wafers with grooves or saw marks on the surface which corresponds to the direction of the wire during sawing. Slurry-sawn wafers in comparison do not exhibit such saw marks. A cropped comparison of a slurry wire-sawn wafer and a diamond wire-sawn wafer is shown in Figure 1.3. These saw marks do have marginal impact to the performance of a solar cell (Bidiville et al., 2009; Seigneur, Schneller, Shiradkar, & Schoenfeld, 2016), nevertheless the efficiency of the technique in terms of speed and cost savings far outweighs the drawbacks.

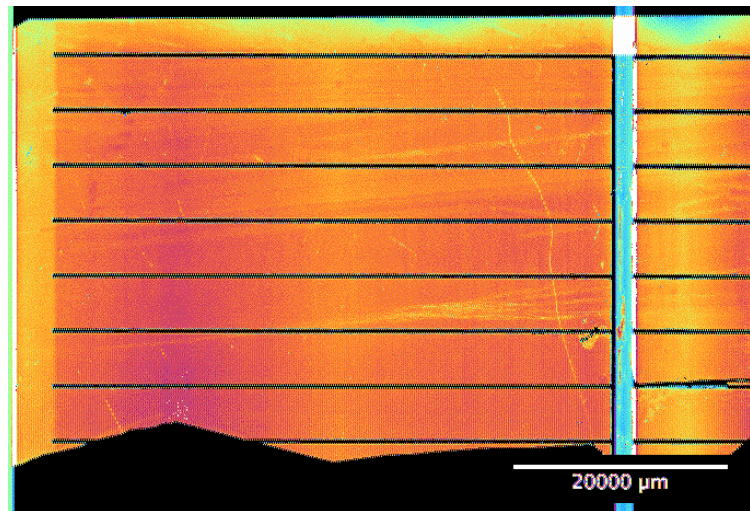
Figure 2.4: A monocrystalline solar cell acquired using LBIC. A micro-crack can be observed running up the cell above the micron scale bar (Colvin, 2009).

The measured current are then recorded and converted into grey scale values to create an image representation of the inspected sample. A large change in the generated current would indicate that the solar cell contains some form of anomaly. This includes micro-cracks, recombination defects and impurities. An example of a monocrystalline solar cell acquired using LBIC is shown in Figure 2.4.

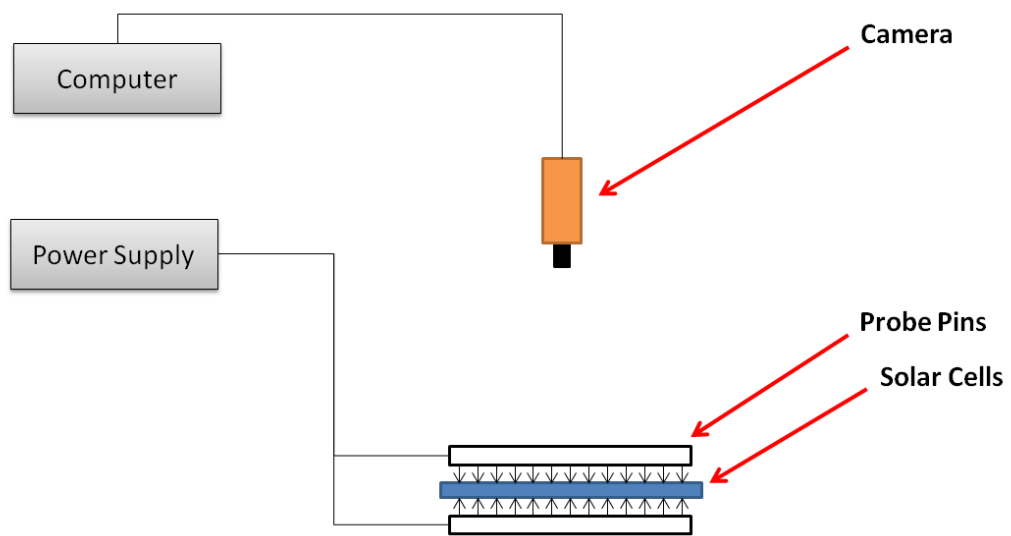
(a) Dark LIT.

(b) Illuminated LIT.

Figure 2.5: Schematic layout of a dark and illuminated LIT system showing important elements.

There are two techniques to perform LIT, the dark LIT and illuminated LIT. The former works by applying an electrical current in reverse bias to a solar cell by means of electrical contact probes to the front and rear busbars of a solar cell to concentrate the current in shunts, while the latter uses a light source to do the same (Breitenstein, Warta, Schubert, & Langenkamp, 2018). Illuminated LIT could work with silicon wafers and solar cells, while dark LIT will only work with fully completed solar cells as electrical contacts are required. Figure 2.5 shows typical layouts of both LIT systems.

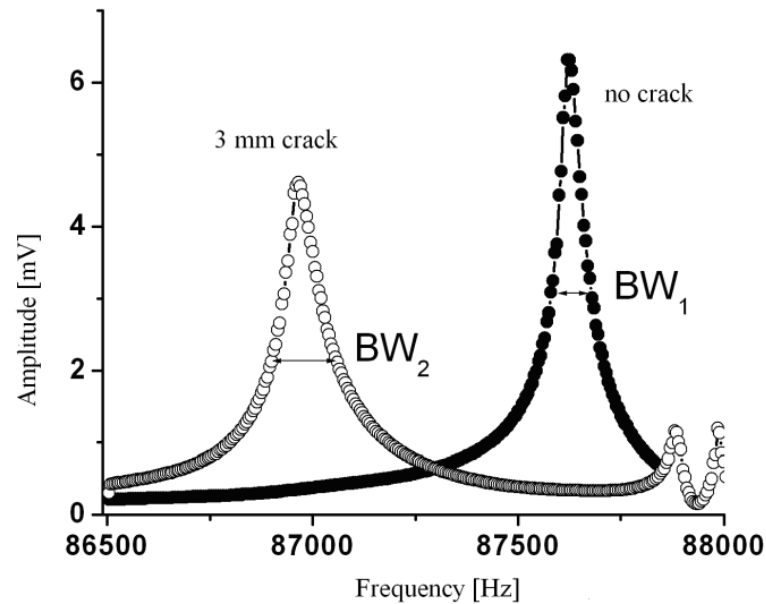
Figure 2.8: A example of an frequency response curve generated by a RUV system showing the difference between an intact solar cell and a micro-cracked one (Monastyrskiy, 2008).

The resonance frequency response curve can then be analysed to detect defects. In the case of micro-cracks, three rejection criteria are used (Monastyrskiy, 2008): (1) shift of the peak position downward; (2) increase of the bandwidth, and (3) reduction of the amplitude. Figure 2.8 shows an example of such a frequency response curve.

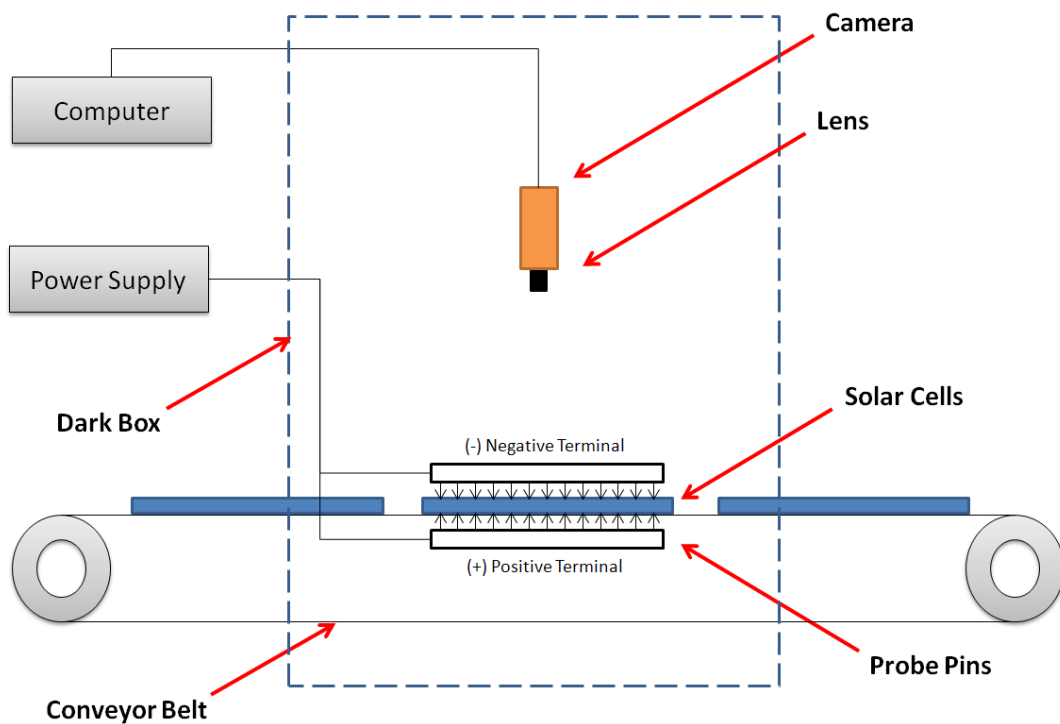
Figure 2.9: Schematic layout of an in-line EL system showing important elements.

An EL system consists of a NIR sensitive camera and electrical probes connected to a power supply. Figure 2.9 shows a layout of an in-line EL system where a camera is placed directly above a probe station. The probe station would contain a set of pogo pins to deliver an electrical current to the front and rear busbars of a solar cell. A forward bias current would be applied to the solar cell at around 30 – 35 mA/cm²

and an open circuit voltage of 0.55 – 0.65 V, which would correspond to the typical short circuit current under 1 sun solar irradiation (Fuyuki, Kondo, Kaji, Ogane, & Takahashi, 2007). Typical EL emission of light peaks at about 1150 nm in the NIR spectrum (Fuyuki & Kitiyanan, 2009).
