**AN EXPERIMENTAL INVESTIGATION ON THE
PERFORMANCE OF THE MODIFIED
CONNECTION OF OVERHANG ROOF STEEL
CLADDING SUBJECTED TO STATIC LOAD**

**SCHOOL OF CIVIL ENGINEERING
UNIVERSITI SAINS MALAYSIA
2021**

BACHELOR OF ENGINEERING (HONS.)

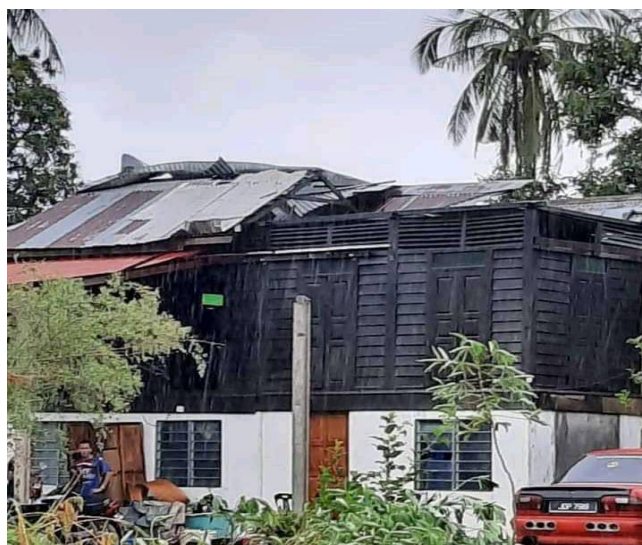
Figure 1.1 Roof damage during windstorm event

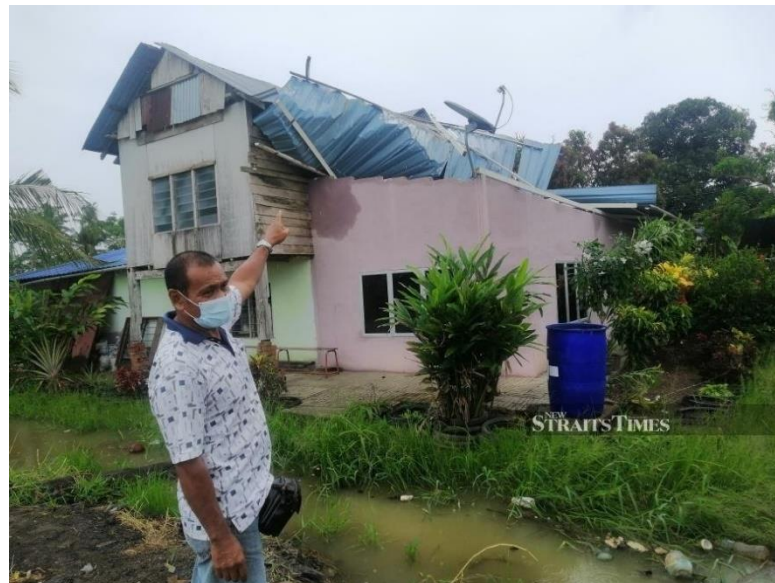
Figure 1.2 Roof damage in Indera Mahkota Dua, Kuantan (New straight times, 30 October)

There have been several reports of wind damage incidents in recent years, which have been widely documented in the media. These occasions have carried genuine inability to the rooftop structure where it typically started at cladding and purlin connection. As of late, there is one case revealed by New Straits Times paper on 30th October 2020 including windstorm occasion happened at Kuantan, Pahang. The windstorm has ripped through residential neighbourhoods in the area causing several homes' roofs to be swept away. Around 37 premises were reported damaged during the event that lasted about an hour starting from 8pm. The occasion has caused structural damage to number of houses such as damaged roofs and broken ceilings which resulted in rain damaging the furniture inside the house as shown in the Figure 1.2.

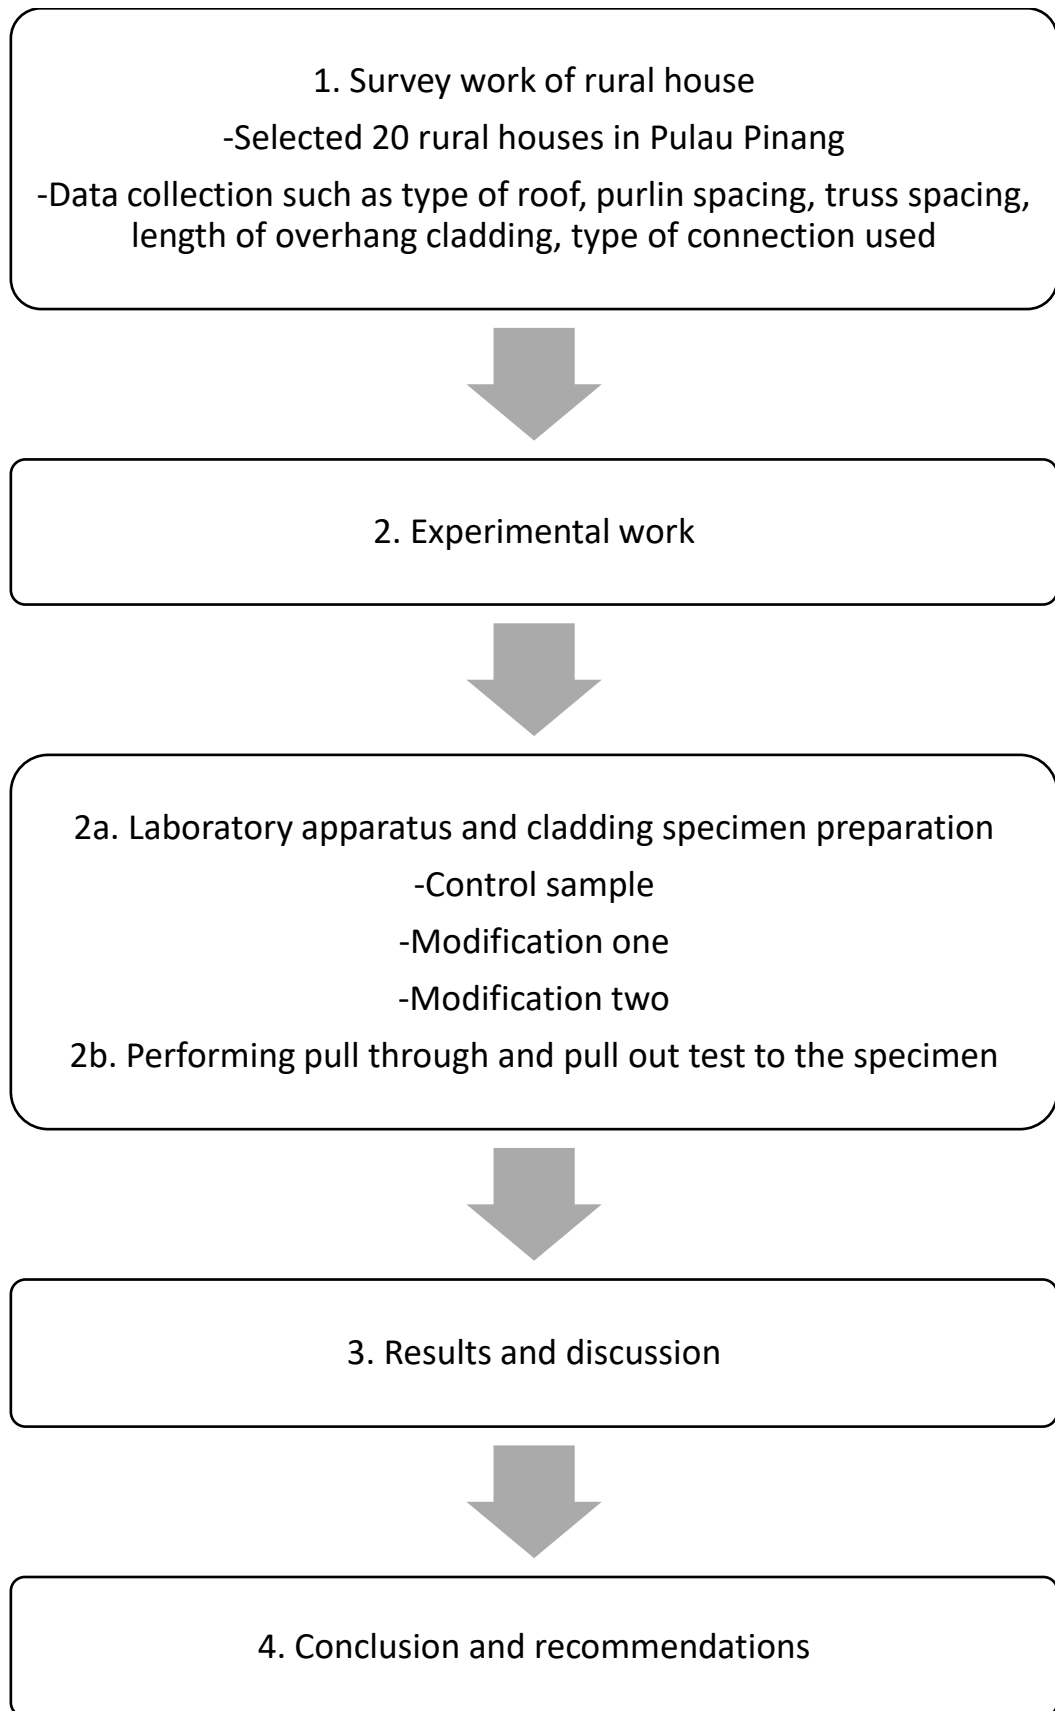
Figure 3.1 Flowchart of the study

The focus of this study is to determine the performance of various modified connections of steel cladding to the purlin at the overhang by using pull-through and pull-out test considering the pull-through and pull-out load capacity. The study comprises of two parts which are rural house survey and experimental work. The survey of rural house took place only in one district in the state of Pulau Pinang, namely Sungai Kechil. The data of the site activities with numbers of houses participating were shown accordingly in this chapter. This chapter comprises of the brief explanation of the preparation of the specimens, the set up and details on the procedure of pull-through and pull-out test. Meanwhile, the experimental work took place in Heavy Structure Laboratory at School of Civil Engineering, Universiti Sains Malaysia. The flowchart of the overall methodology including both survey work and experimental work shows in Figure 3.1. There are in total of four stages involved in this study.

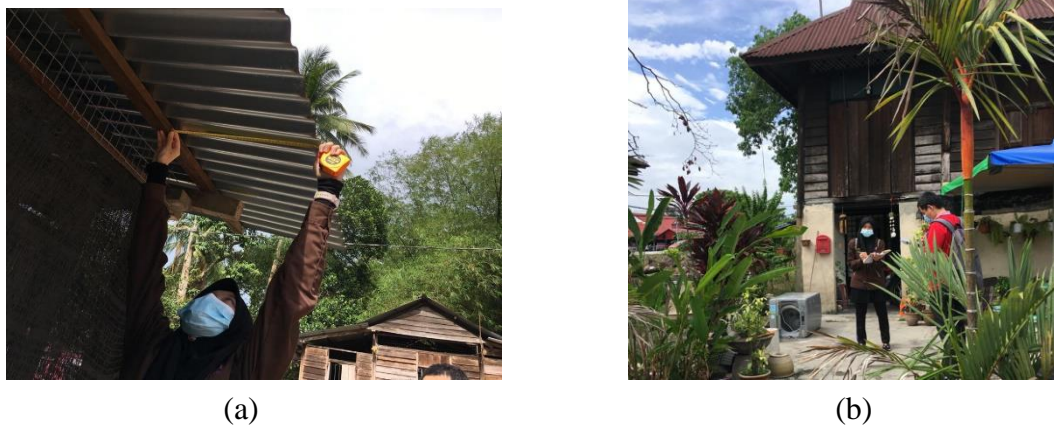
During the rural house survey was conducted, various activities were involved, starting from the site survey, where to find the suitable type of houses to be participating within the requirement of non-engineered rural houses. Next, the process of measuring the dimension of the roof and some other parameters were taking place coherently with the interview participated by the owner of the houses.

Figure 3.3 Activities at site (a) measuring roof overhang and (b) interview session with the house owner

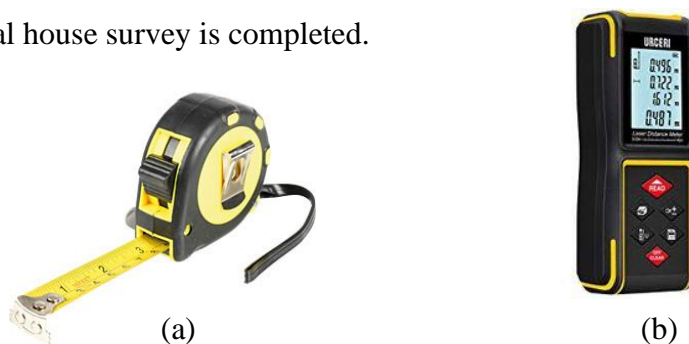
Figure 3.4 Measurement tool used during the survey (a) measuring tape (b) handled distance meter.

The process of measuring the roof dimension was conducted by using two types of equipment, namely measurement tape and handled distance laser meter as shown in the figure 3.4. The data obtained has been recorded under the survey form and the process of rural house survey is completed.

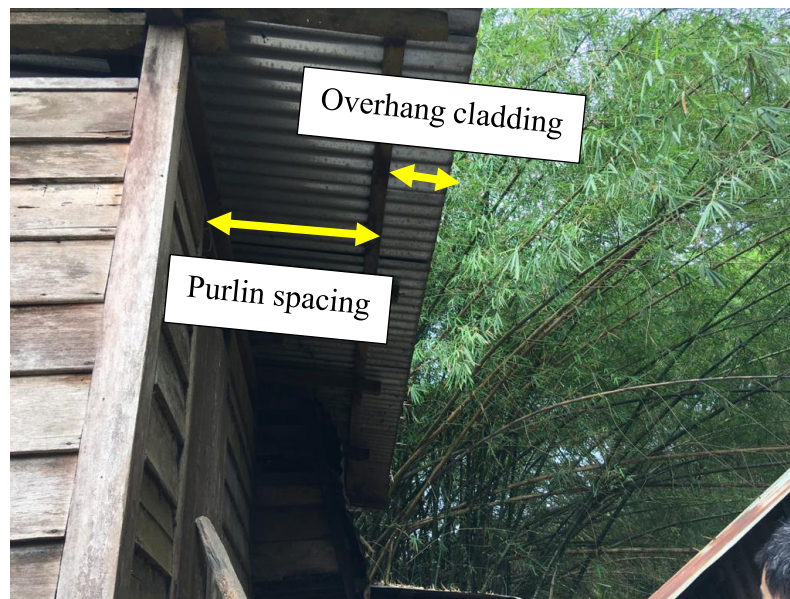
Figure 3.5 Segment of overhang roof which consist overhang cladding and purlin spacing.

Based on the information gathered, it is identified that the structure of the overhang roof of the rural house comprises the combination of purlin spacing (PS) and overhang cladding (OC). The first part of the overhang roof is the purlin spacing, it covers the area from purlin to purlin, where usually the first purlin is located at the end of the wall of the building and the second one is away from the building and near to end of the overhang roof cladding. Meanwhile, the second part of the overhang roof covers from the second purlin to the end of the overhang roof cladding, namely as overhang cladding. Figure 3.5 shows the structure of the overhang cladding of one of the houses participated during the survey was conducted.

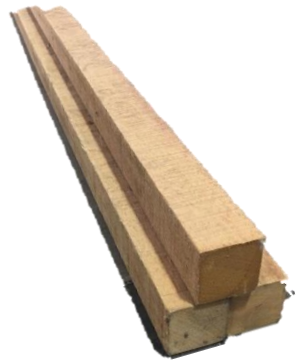
Figure 3.8 Jelutong was used as purlin

The timber used in this experimental work known as Jelutong, this type of timber is categorized under strength group 6 (SG6). Based on the class of the timber, it is notable that this type of timber is relatively weak. Therefore, it is easy to be purchased due to its low cost. The dimension of the purlin used is 50 mm x 50 mm and the length of 1220 mm as shown in Figure 3.8.

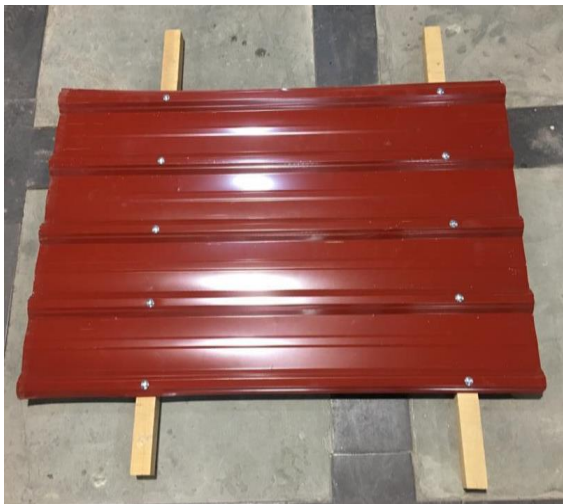
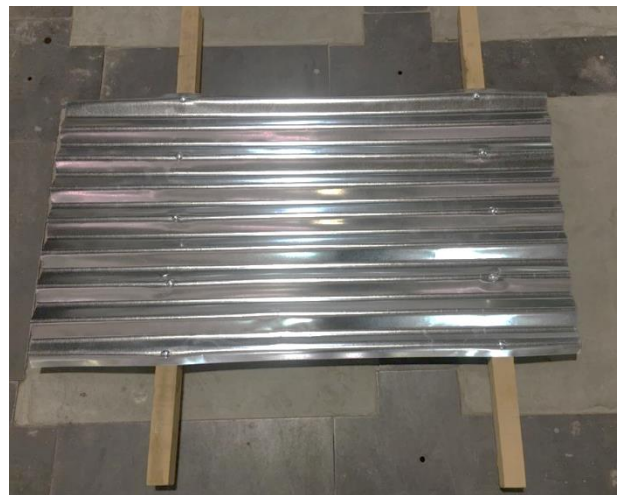
Figure 3.11 Control sample for both roof type (a) trapezoidal steel cladding (b) corrugated steel cladding

The specimen was assembled according to the real roof construction. The information gathered during the survey of rural houses was used as the guidelines to reproduce the identical structure of roof. Based on the data collection, the overhang cladding is 150 mm, purlin spacing is 750 mm, and the connection used is umbrella nail head. Thus, the roof is being prepared accordingly as shown in Figure 3.11. The result of testing for the control sample will be used as the benchmark in this experiment.

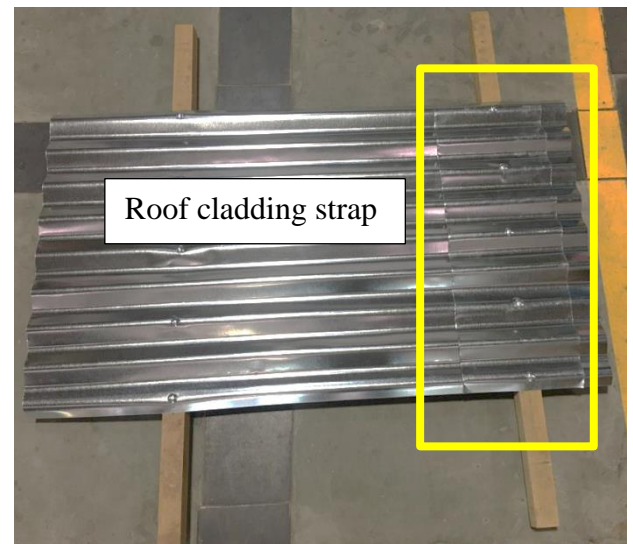
Figure 3.12 Modification one sample with addition of roof cladding strap for both roof type (a) trapezoidal steel cladding (b) corrugated steel cladding

In this experimental work, some modifications were made to the connection of roof cladding to the purlin. The first modification idea was by adding a piece of roof cladding strap on top of the roof cladding. The roof cladding has been laid parallel to the purlin that located near to the overhang cladding and secured by the umbrella head nail. The structure of the roof is basically the same with the control sample, but with the addition of roof cladding strap on top of the roof cladding as shown in the Figure 3.12.
