**THE IMPACT OF UPLIFT FORCES ON THE
CONNECTION OF STEEL CLADDING FOR
RURAL HOUSES IN MALAYSIA**

**SCHOOL OF CIVIL ENGINEERING
UNIVERSITI SAINS MALAYSIA
2021**

**BACHELOR OF ENGINEERING (HONS.)
(CIVIL ENGINEERING)**

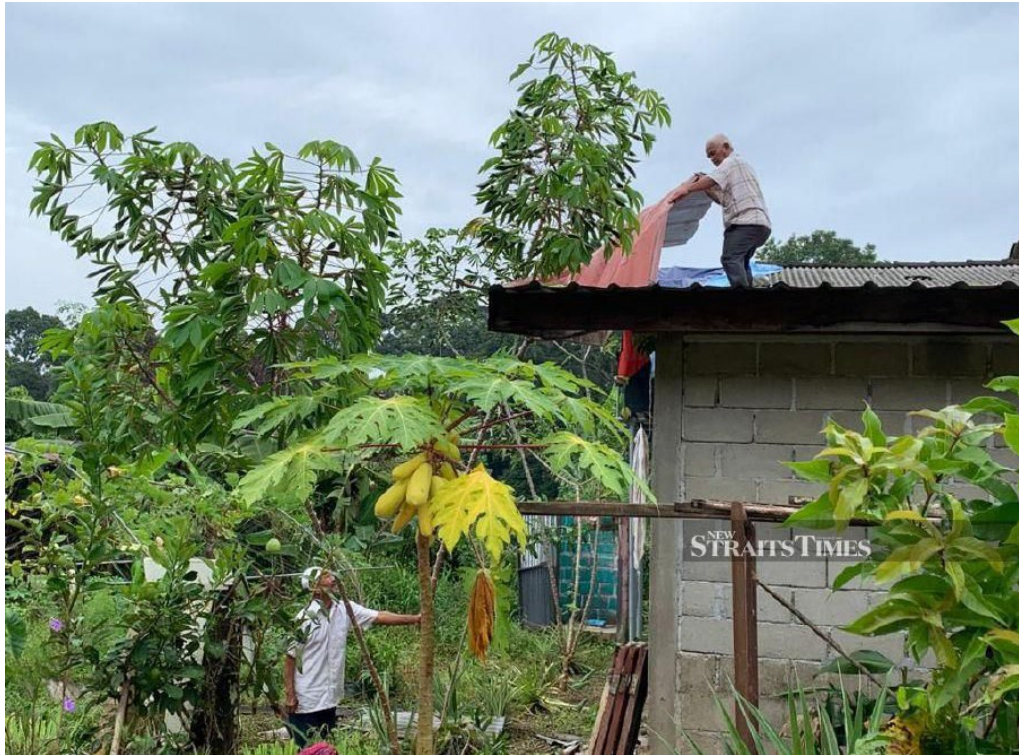
Figure 1.1 Damaged roof cladding after windstorm in Kampung Likong, Kota Baru, source (NST, 2020).

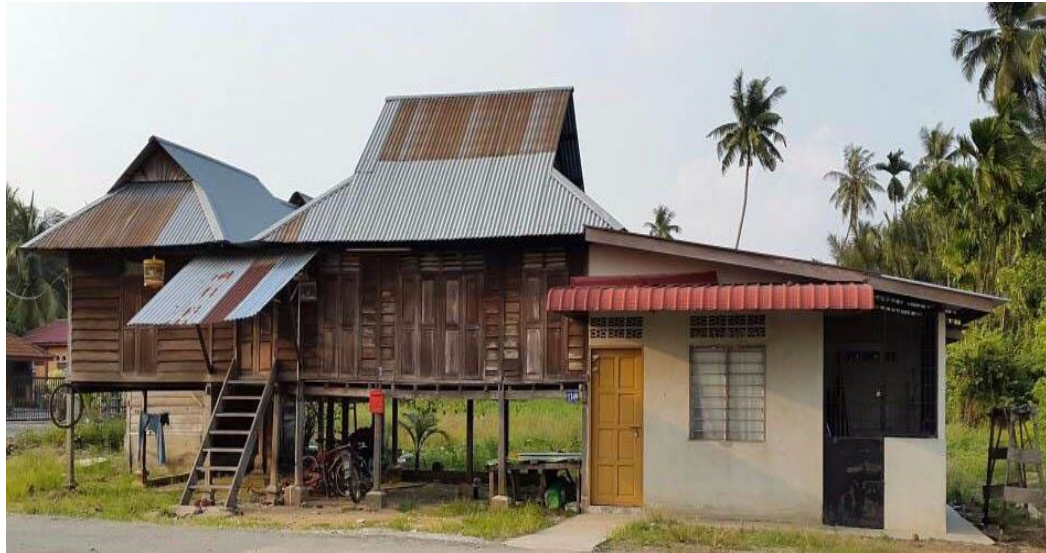
Most of the rural houses in Malaysia that that were damaged especially the roofing system were built without following any building codes and engineering guidance (Zainorizuan et al., 2017). As shown in Figure 2.1, the one story rural house commonly built in Malaysia was constructed using timber walls and timber truss with a steel cladding sheets for the roof.

Figure 2.1 A rural non-engineered house in Malaysia, source (Muhammad et al., 2015)

Malaysian rural houses usually made out of the affordable local materials available in the area, timber is the main component of the house, for the frame system, and wooden walls, beside the metal roof cladding sheets and nails for the roof connections (Muhammad et al., 2015).

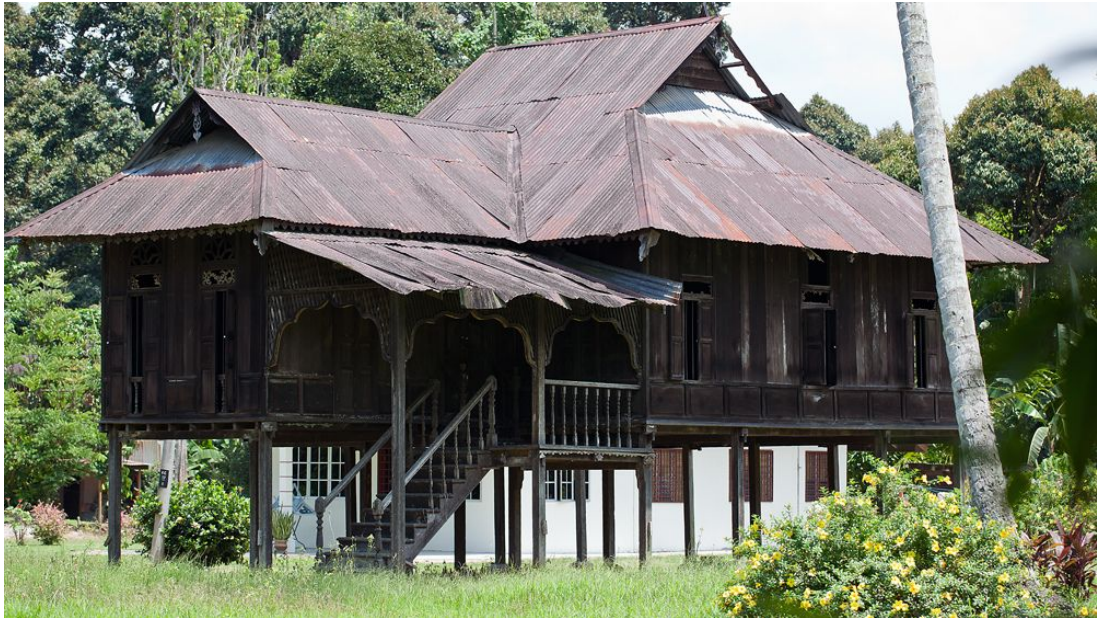
The author Zainorizuan et al. (2017) declared that most accustomed types of roofing system geometry are the simple gable roof geometry and the Dutch gable roof geometry (Figure 2.2).

Figure 2.2 Typical Dutch gable roof house in Malaysia, source (Flickr, 2010)

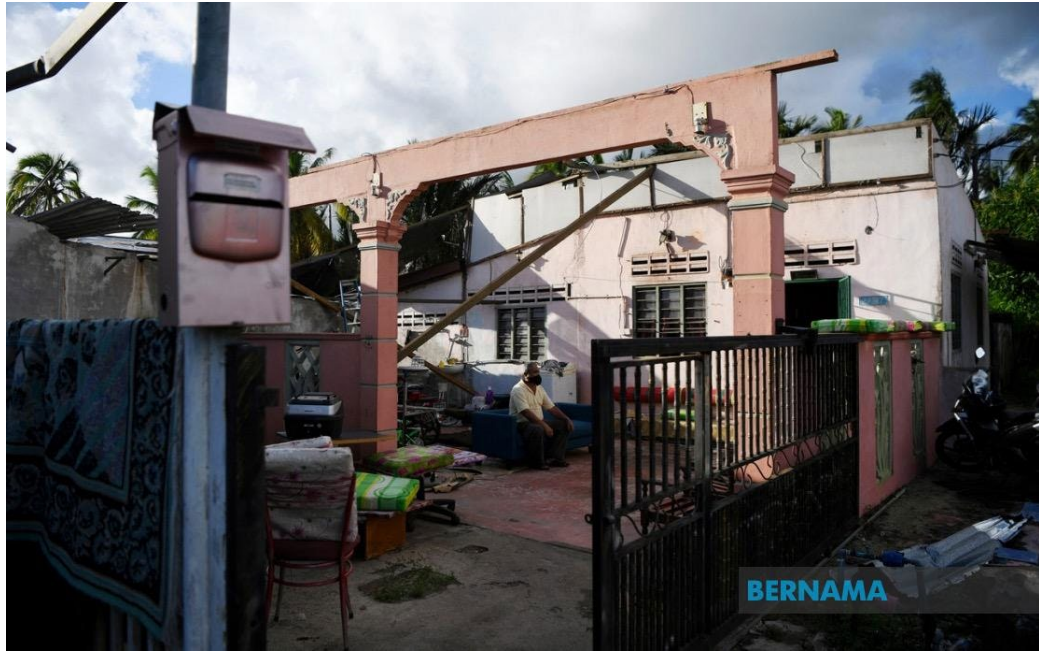
Roofing system were lead the most affected part of building during the windstorms (Majid et al., 2016). As shown in Figure 2.3, the roof was blown out due to very heavy storm in Kuantan 25 March 2021.

Figure 2.3 Damaged roof after a heavy storm in Kuantan, source (BERNAMA, 2020).

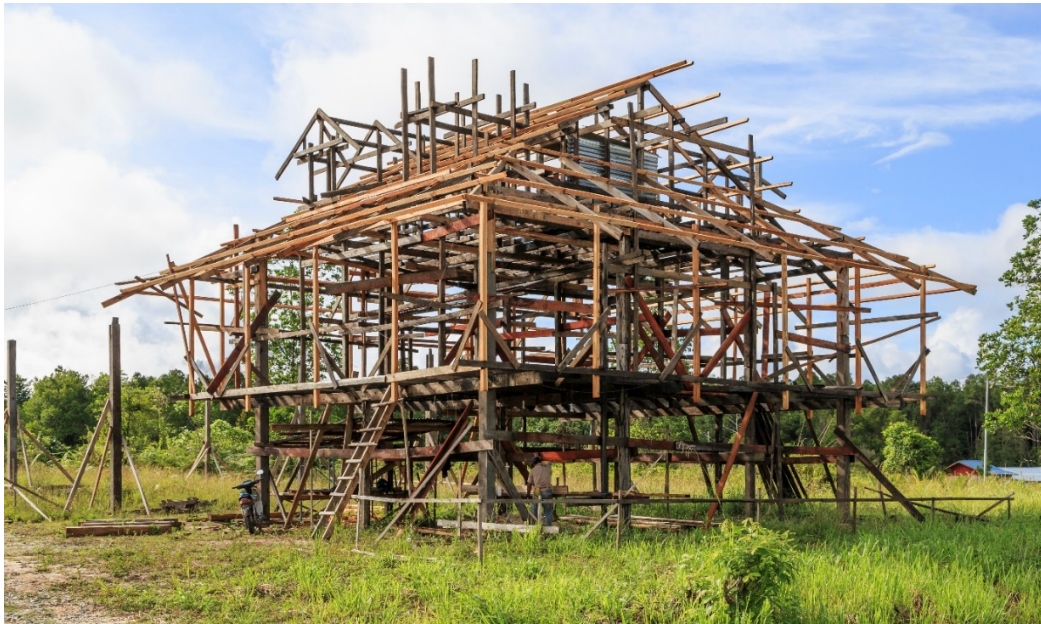
In Malaysia, most of the fasteners used for cladding purlin connection were Umbrella head nail and Umbrella head nail with rubber washer (Majid et al., 2020). The roof steel cladding are vulnerable during the typhoons or monsoons (Ji et al., 2018). The majority of the damaged cases in the roof were due to connection failure as compared to the roof frame (Kopp et al., 2012, Morrison et al., 2012).

Figure 2.4 Rural house under construction in Sabah, source (CEphoto, 2014).

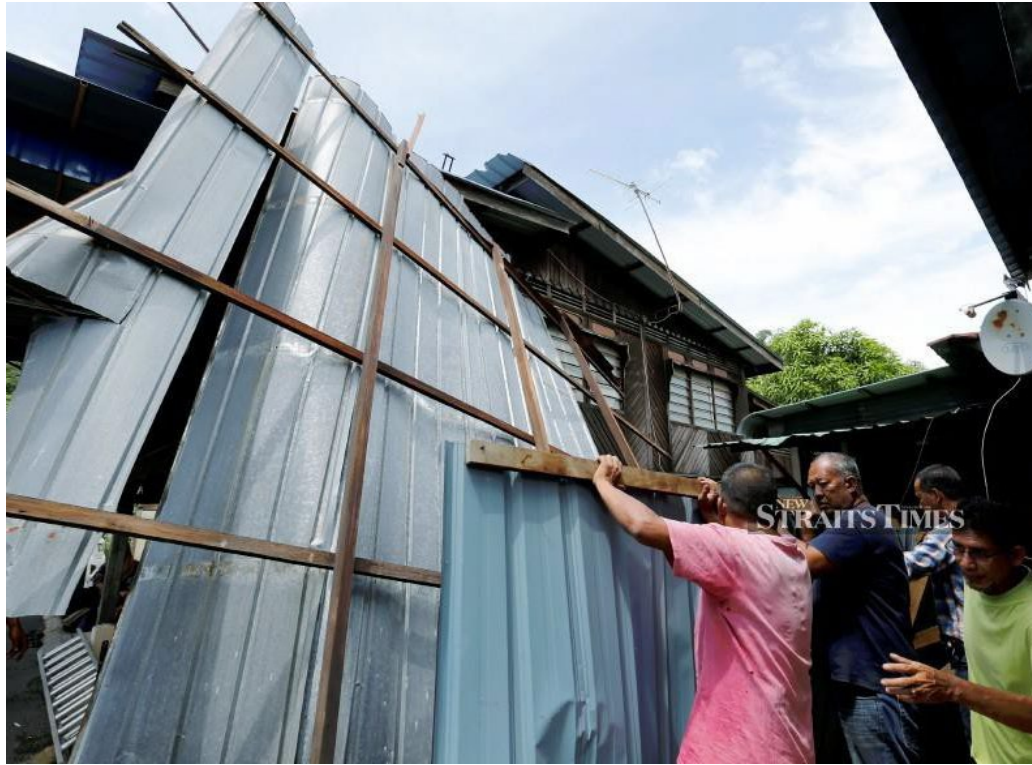
The failure of steel roof cladding was relied upon various factors, such as geometry of roof system, fastener type, cladding thickness, and connection positions. Figure 2.8 shows the failure caused by the form of pull through of the fastener.

Figure 2.8 Damaged roof due to windstorm in Kuala Juru, Penang, source (NST, 2019).
