AN EXPERIMENTAL INVESTIGATION ON PULL  
THROUGH FAILURE OF ROOF CLADDING TO  
PURLIN CONNECTION CONSIDERING OVERHANG  
ROOF

SCHOOL OF CIVIL ENGINEERING  
UNIVERSITI SAINS MALAYSIA  
2019

**BACHELOR OF ENGINEERING (HONS.)  
(CIVIL ENGINEERING)**

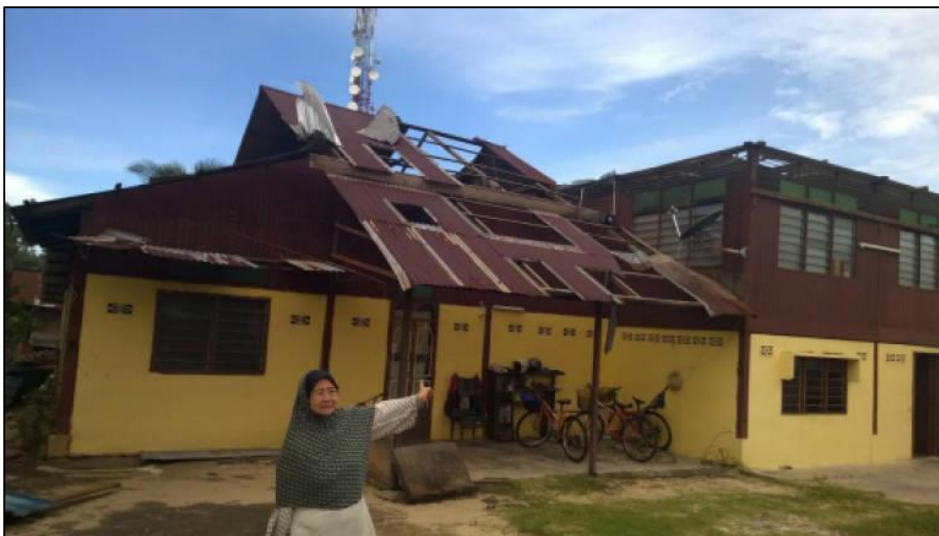
Figure 1.1 Roof damage during strong wind event

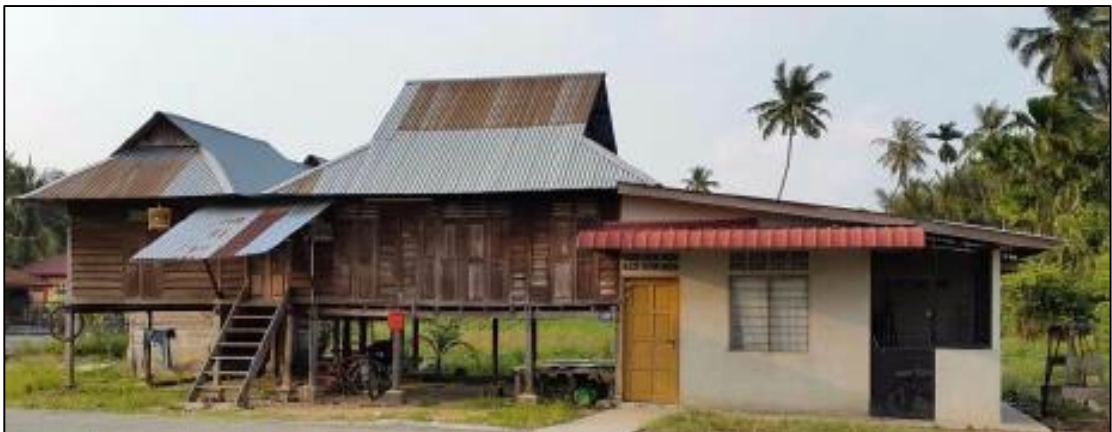
Figure 2.1 Typical house of rural area in Malaysia ( Muhammad et al., 2015)

Recently, number of wind related disaster due to windstorm event had increased tremendously in Malaysia. According to Mahendran and Mahaarachchi (2002) low-rise buildings have higher tendency to damage caused by extreme wind events such as windstorm. Figure 2.1 shows, the housing in rural area in Malaysia which is particularly is non-engineered structures and low-rise buildings. This type of house is prone to destruction when subjected to high wind loading (Muhammad et al., 2015). This is because low rise buildings have low pitched roof and weak link of uplift load path (Mahendran, 1995). Such large number of non-engineered low rise buildings are not able to withstand high-wind events and this will contribute to an extremely large economic loss caused by damage to these buildings.

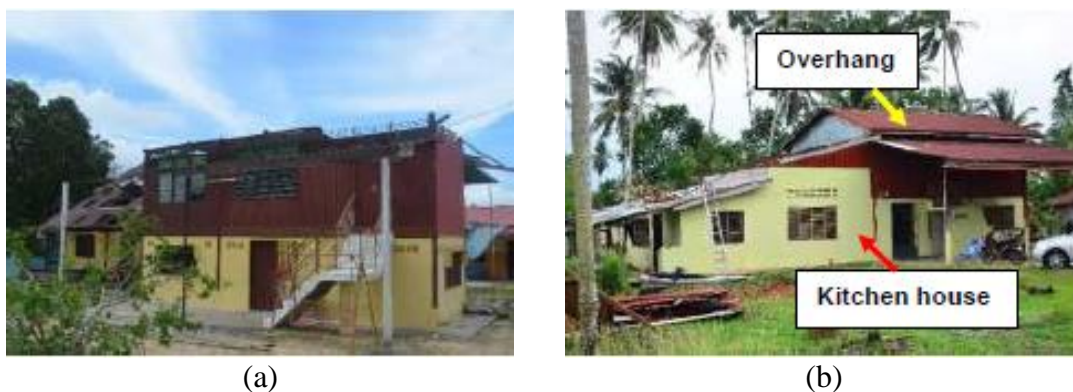
Figure 2.3 Failure of roof that initiate at overhang roof of rural house in (a) Balik Pulau, Penang and (b) Kepala Batas, Penang (Majid et al., 2016)

Northern region of Peninsular Malaysia , a study done by Majid et al. (2016) found that most of the rural houses are designed by having overhang roof. This part of roof located at the edge of the roof and protruding outwards where its function to protect the wall façade during heavy rain. However, Zaini et al. (2017) stated that due to inadequate support to hold the roofing system from uplift might initiate the damage at overhang especially during strong wind event. Figure 2.3 shows example of failure of roof that initiate that initiate at overhang roof of rural house in Penang.

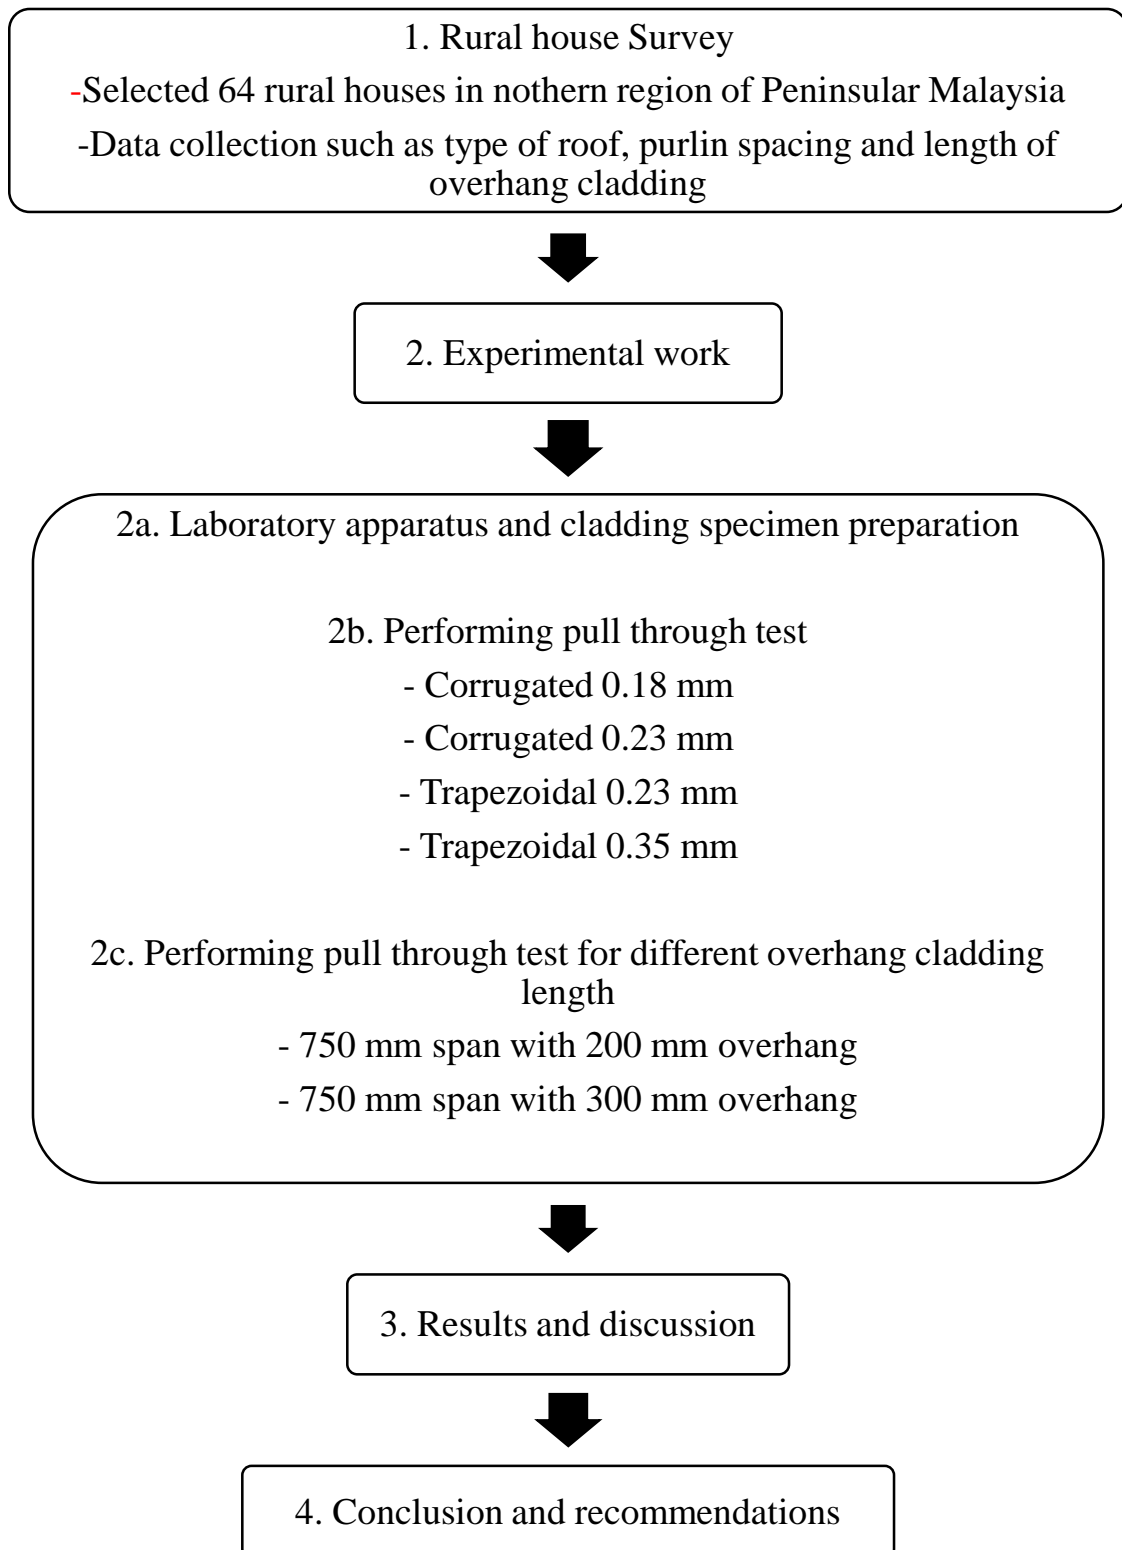
Figure 3.1 Flowchart of the study

The aim of this study is to determine pull through load capacity of various type of cladding with different thickness at overhang using pull through test. The study consists of two parts namely, rural house survey and experimental work. The rural house survey covers several districts in Kedah, Penang and Perak. Details of the site activities were presented accordingly in this chapter. Following this, the overview of the specimens' preparation, the test set up and the details on the procedure of pull through test are presented. The test was conducted at Heavy Structure Laboratory located at School of Civil Engineering, Universiti Sains Malaysia. The duration for conducting both rural house survey and experimental works took about 3 months starting from 1<sup>st</sup> December 2018 until 23<sup>rd</sup> April 2019. Figure 3.1 shows the flowchart of the overall methodology for rural house survey and experimental work. There are four steps involved in this study .

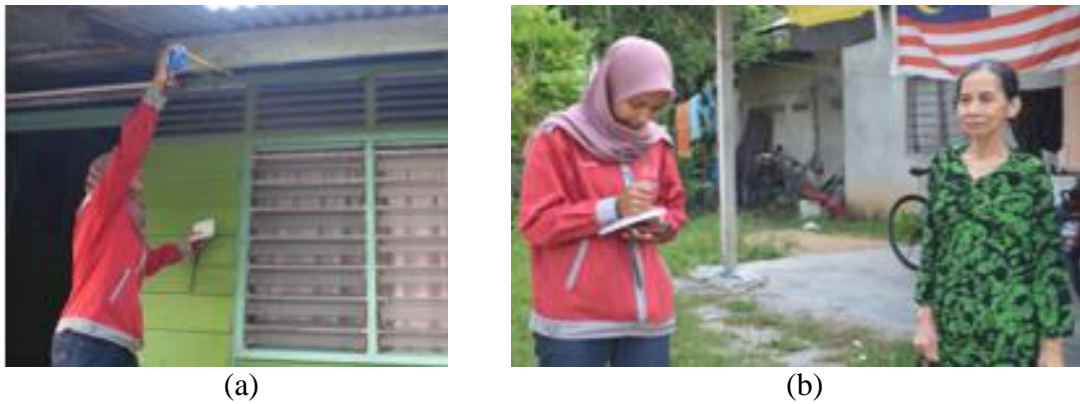
Figure 3.3 Activities at site (a) measurement of roof overhang and (b) interview session with house owner

Various activities were involved during rural house survey like site visualisation, roof house measurement and interviewing the house owner as shown in Figure 3.3.

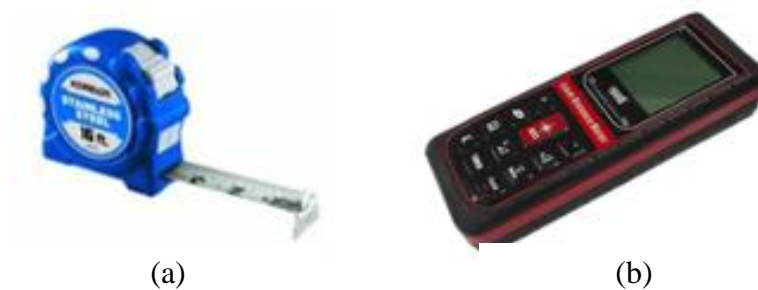
Figure 3.4 Measurement tool used in rural house survey (a) measuring tape an (b) handled distance laser met

Rural house survey mainly being done to measure the roof part of house The measurement included dimension of roof especially on overhang roof and overhang zinc. The measuring tape and handled distance laser meter as shown in Figure 3.4.

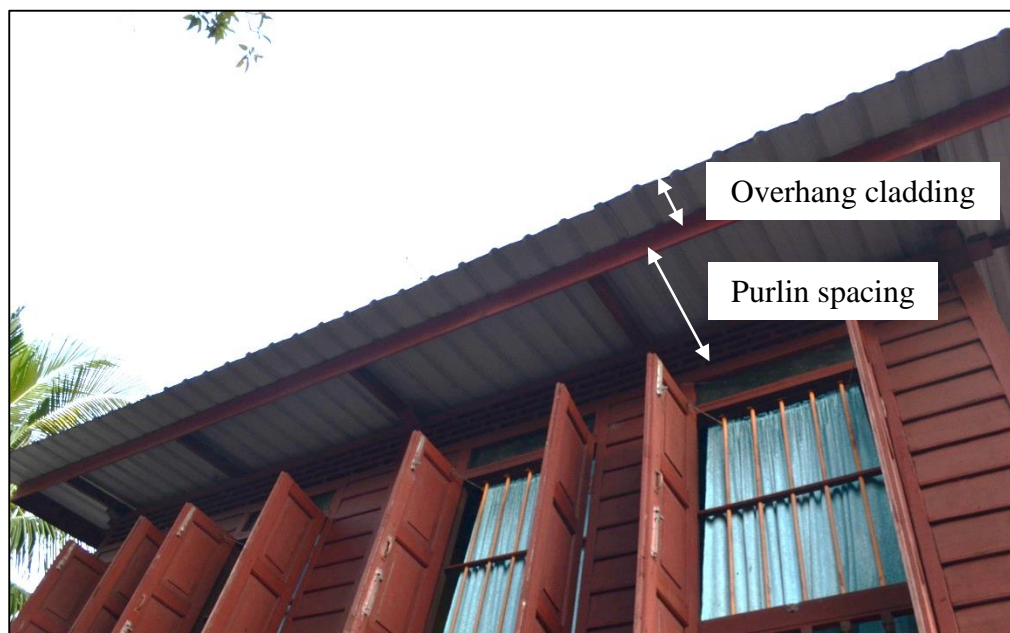
Figure 3.5 Part of overhang roof comprised of purlin spacing and overhang cladding

In rural house survey, overhang roof is defined as combination of purlin spacing (PS) and overhang cladding (OC). Purlin spacing is a part of overhang roof from the end of the wall until the overhang cladding. Meanwhile, the roof part from the end of purlin until the overhang cladding is called overhang cladding. Figure 3.5 shows the part of overhang roof involved in rural house survey activities and schematic diagram of overhang roof is shown in Figure 3.6.

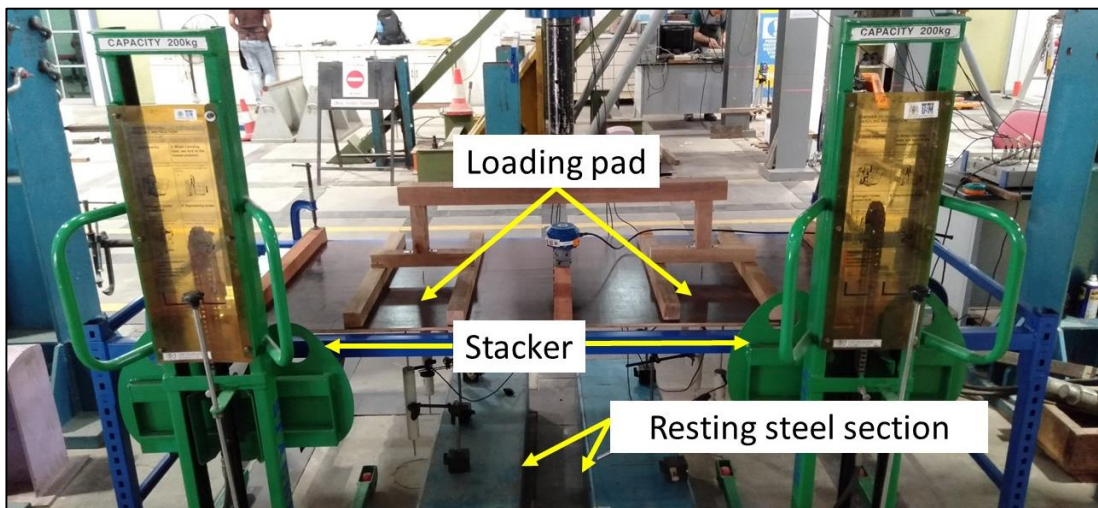
Figure 3.12 Main component in the experimental set up

As the cladding was set up upside down on the steel frame assembly measuring 950 mm width  $\times$  2530 mm long  $\times$  710 mm height, the purlin need to be clamped on the steel frame assembly using G-clamp. The cladding was placed inversely on the steel frame assembly to simulate the uplift wind loading acting on it. There are three main components namely jointed loading pad, stacker, resting steel section as shown in Figure 3.12. The jointed loading pad designed to distribute load from the hydraulic testing machine to the cladding. The stacker was used to avoid the cladding from hit on the LVDT directly and resting steel section was placed to provide the base for LVDT to be installed. The schematic diagram for the pull through test are shown in Figure 3.13.

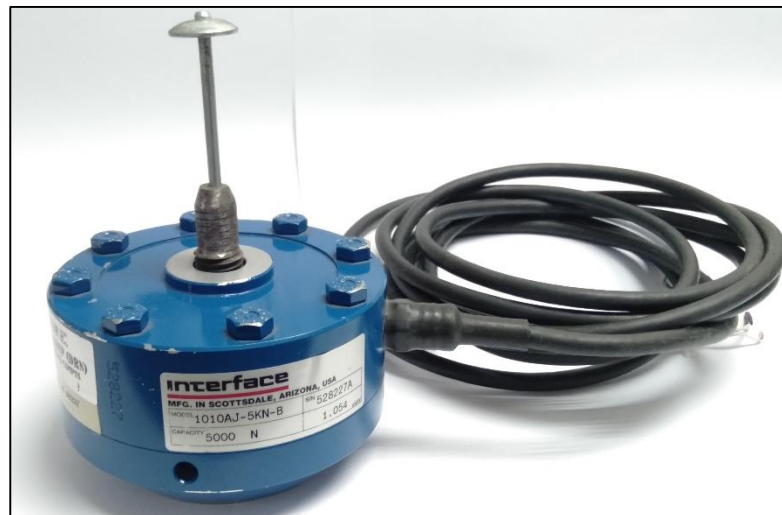
Figure 3.14 Load cell of 5 kN load capacity with modified screw fastener

The experimental work used modified umbrella head nail to simulate the pull through capacity of the fastener. The modified nail fastener is attached to the load cell as shown in Figure 3.14.

A 5 kN load cell was placed on top of the central fastener head to measure the reaction. The modified nail fastener is attached into the load cell in order to obtain the pull through capacity. As such, the central fastener was not fastened to the timber purlin but it is fixed to the load cell. It is important to ensure the load cell not in contact with the timber purlin so that the real reading not affected.
