**CONSERVATION OF HERITAGE BUILDING  
FAÇADE; THE CASE STUDY OF TRADITIONAL  
TOWER HOUSES IN OLD SANA'A, YEMEN**

**2024**

**Thesis submitted in fulfilment of the requirements  
for the degree of  
Master of Science**

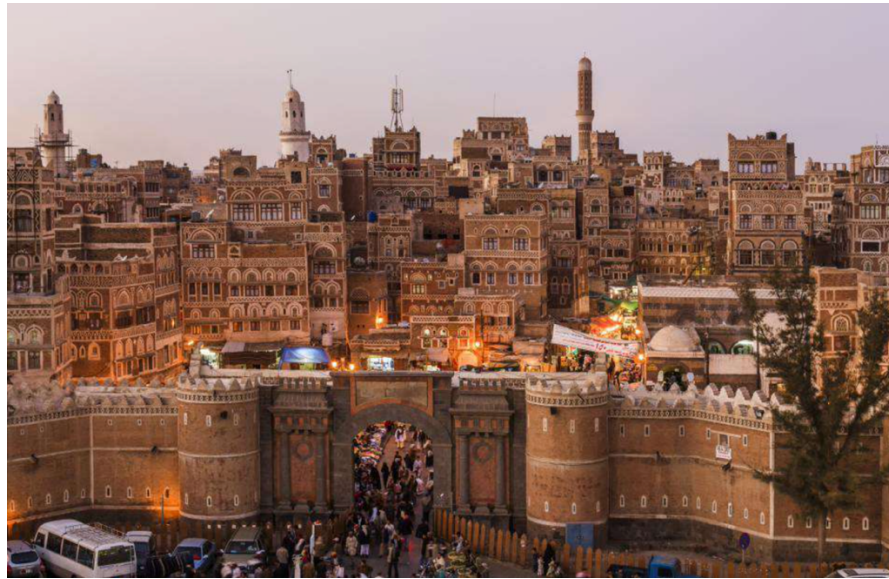
Figure 1.2 Old Sana'a (South Gate). Retrieved from <https://yemenat.net/?s=old+Sana%27a>

The tower houses of Old Sana'a, as illustrated in Figure 1.2, with their distinctive architectural style and construction techniques, are a defining feature of the city's cultural landscape. These multi-story structures, built primarily of rammed earth and burnt brick, are adorned with intricate geometric patterns and decorative elements, showcasing the ingenuity and artistry of Yemeni builders. They are not merely dwellings; but a testament to the city's rich history, cultural traditions, and unique way of life (Attia, 2022). Figure 1.3 highlights the significant percentage of tower houses

growth and expansion. The city was fortified with a clay wall, and four main gates (Bab al-Yemen, Bab Shaoub, Bab al-Sabah, and Bab Satran, as seen in Figure 1.2), and the Al-Qalis Church was established, marking a period of Christian influence.
