**SLOPE FAILURE ASSESSMENT
IN PENANG ISLAND
USING GEOELECTRICAL METHODS**

**Thesis submitted in fulfilment of the requirements
for the degree of
Master in Science**

April 2018

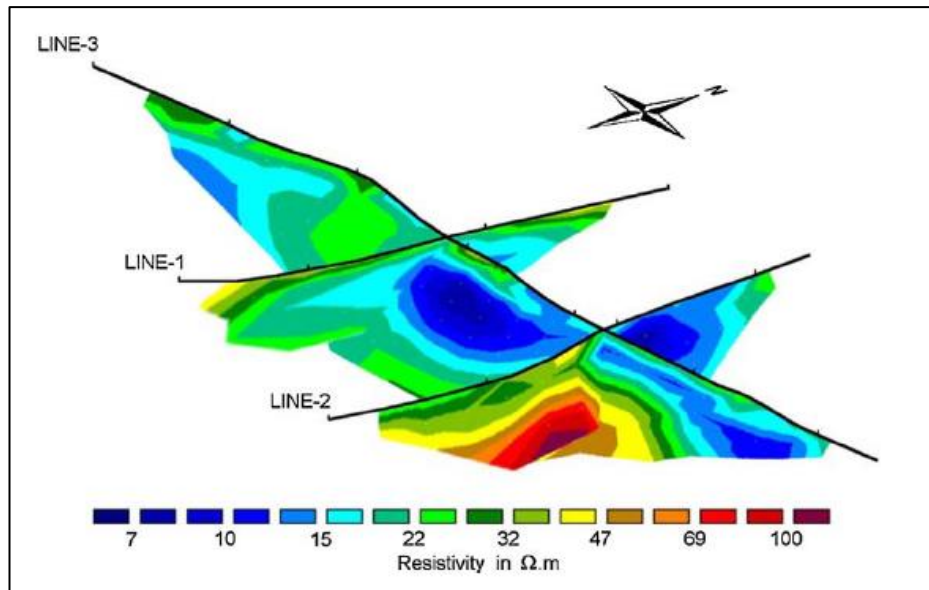
A study of landslide was conducted by Drahor et al. (2006) at district of Aydin, Turkey in 2003 on a slope next to a newly built school building. The slope was unstable due to an excavation work and heavy rainfall. Three resistivity survey lines were conducted over the landslide using Wenner electrode array resulting on the geometry and characteristic of the landslide. Eight boreholes were also carried out on the landslide. Both methods showed a fault presence at the area with addition of a surface rupture indicated by the resistivity profiles (Figure 2.3).

Figure 2.3: 3D fence diagram for resistivity section in Aydin (Drahor et al., 2006).

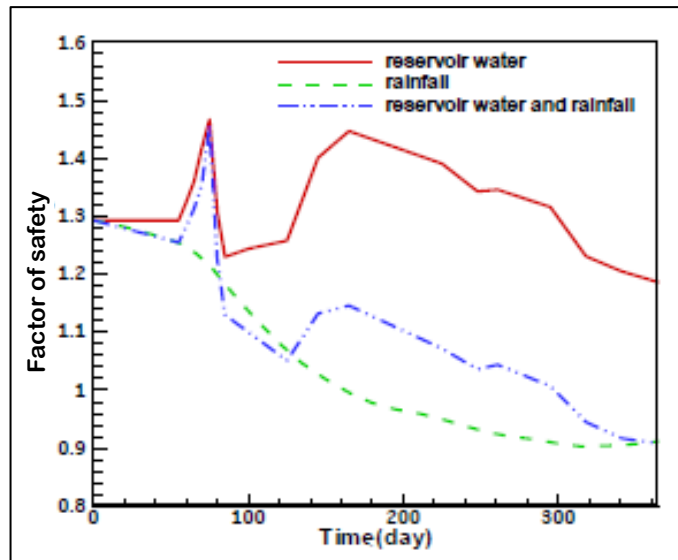
A water – seepage coupling model and stability analysis was developed to study the effect water on the soil – slope stability by Liu and Li (2015). In order to analyse the effect of water seepage which came from rainwater and water level fluctuation, safety factor of slope by rainfall and water level fluctuation was simulated. The simulated result indication that both rainfall and water level fluctuation decreased slope stability according to the safety factor of the slope (Figure 2.6). The reason for this phenomenon is increased in total soil weight and slight improvement of pore pressure in slip surface. Therefore, slope stability is highly affected by rainfall and water level fluctuation.

Figure 2.6: Safety factor caused by reservoir water, rainfall and combination of rainfall and reservoir water fluctuation (Liu and Li, 2015).
