MANAGING STRUCTURE RELATED RISKS FOR
HIGHWAY TUNNELLING PROJECT IN MALAYSIA:
A CONTINGENCY PLAN FOR MENORA TUNNEL

SCHOOL OF CIVIL ENGINEERING
UNIVERSITI SAINS MALAYSIA
2018

**BACHELOR OF ENGINEERING (HONS.)
(CIVIL ENGINEERING)**

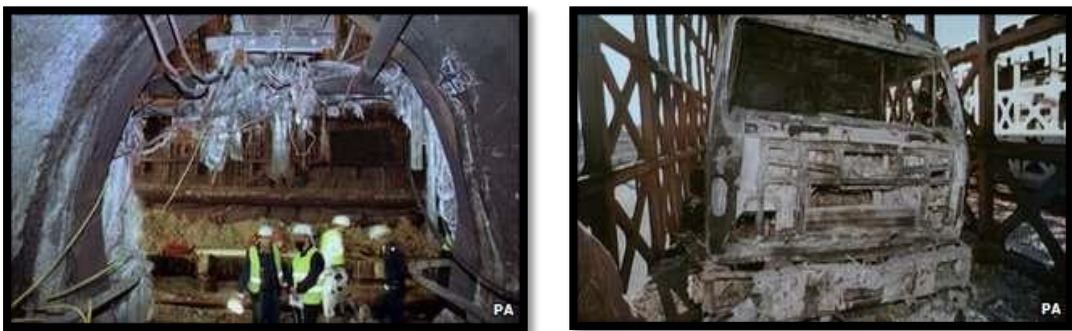
Figure 2.1: The infrastructure of Channel Tunnel was damaged and a fire on a truck caused a great deal of damage during 2008 fire incident (Sources: Carvel, 2010)

The 2008 fire incident can be summarized as below:

- The fire started near the front of the train (it was visible by the passengers)
- The fire extended along most of the length of the train (the damage to the tunnel was 170m- i.e. approximately 8 wagons- longer than In the 1996 fire, which involved almost half the train.

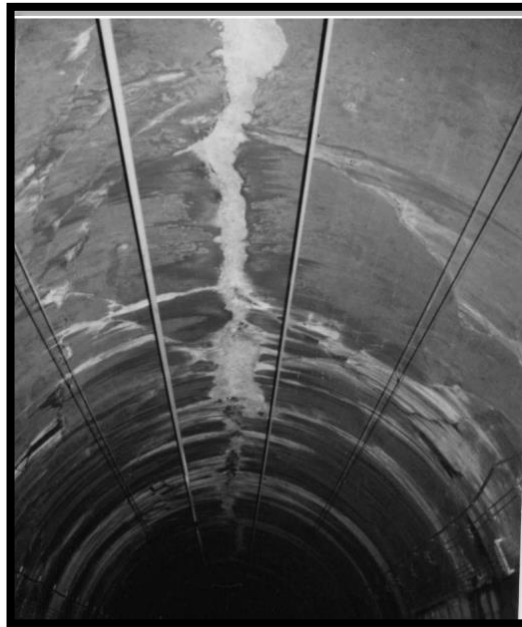
Figure 2.2: Compressive failure caused a longitudinal crack line in the Tsukayama Tunnel (Sources: Asakura & Kojima, 2003)

Shortly after the construction of the tunnel is completed, the tunnel is deformed in such a way that both sidewalls were pushed into the tunnel space accompanied by mud-pumping at the tracks and heaving at the base. The arch crown was pushed upwards and failed in a bending and compressive manner.

As a countermeasure against this deformation, invert concrete was installed to close the tunnel section. According to the convergence measurements between the sidewalls, the convergence had reached a maximum of 40 mm/year before the installation of the invert concrete. This was still not completely subdued by the installation of the invert concrete.

Twenty years later in 1990, however, a relatively wide area of the crown settled where compressive failure had occurred, and many shear cracks developed in a radial manner with their centre at the settled part. The possible collapse of the area was a serious concern.

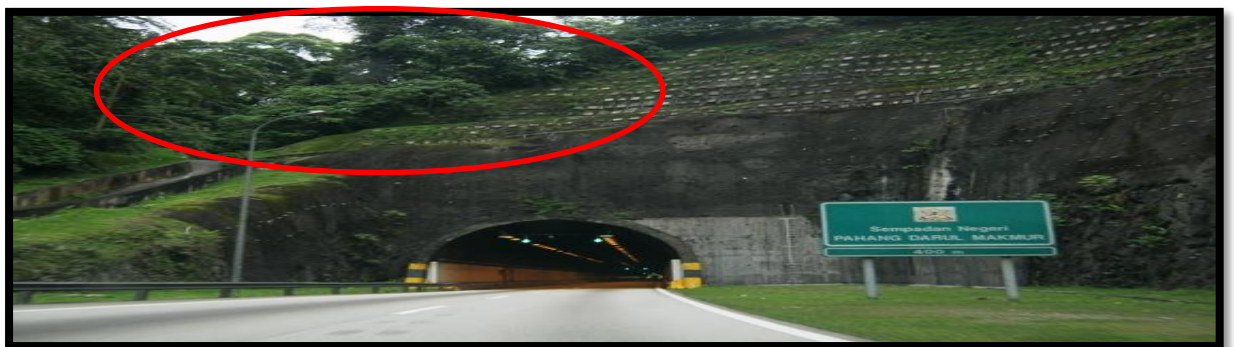
Figure 2.3: Genting Sempah Tunnel located at hill area at Kuala Lumpur-Karak Expressway, Malaysia (Source Nuhu and Maimunah, 2015)

Besides, both Genting Sempah Tunnel and Menora Tunnel are located at the hill area as shown in Figure 2.3 and 2.4 respectively. The possibility of structure failure to be happened is quite high due to exposure toward the excessive load. Therefore, it may eventually cause inability to support the overburden load above the structure.
